Date: 24/1/17

Taupo District Council 72 Lake Terrace Taupo

Condition Report

RE: Air Conditioning of Main Building.

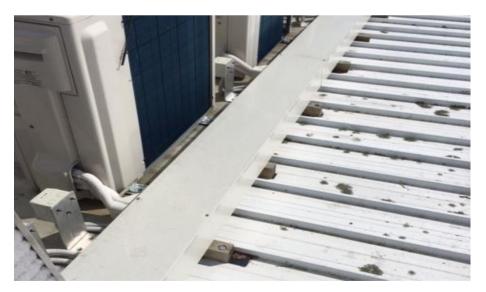
The Panasonic outdoor units have been installed on the roof on timber frames. The anchor bolts through the roof have started to wear and the roof is leaking water to the ceiling below. A better solution is to install all the outdoor units on Monkey Toe mounts.

All outdoor units should be installed on Monkey Toe roof brackets removing the wooden mounts. This will help reduce the deterioration of the roof and reduce the possibilities of water leaks.

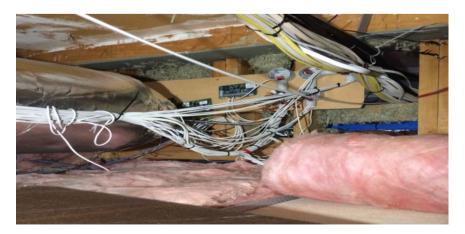
The current ceiling spaces on the ground and top floor are quite congressed with ducting, data cables and power cables. Some of the air conditioning ducting and insulation is redundant and should be removed. The electrical wiring should also be assessed as some of the cables not used have power connected to them.

- Removal of office furniture in the space
- Ceiling grid to be removed and reinstated
- Removal of the ducting and redundant equipment.
- Fire system to be disconnected to prevent false triggers
- Electrical wiring to be assessed and redundant wiring removed. All existing wiring to be tidied and labeled.
- Fire sensors and wiring to be tidied.
- All fire dampers and fire wall assessed and reinstated to code.
- Office personnel to be relocated during this time (could be up to a month)

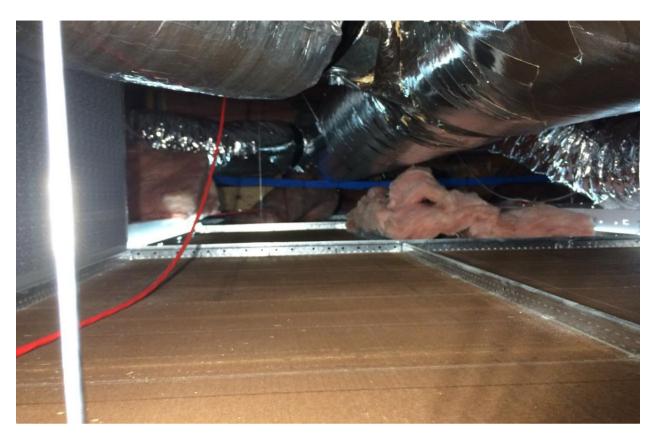
The insulation has been removed in mainly parts of the ceiling tiles.

Once completed the insulation should be replaced and installed correctly on the tiles to provide the required level of insulation. This will reduce the energy losses in heating and cooling and reduce the electrical energy losses as the air conditioning equipment will be operating on a reduced capacity.

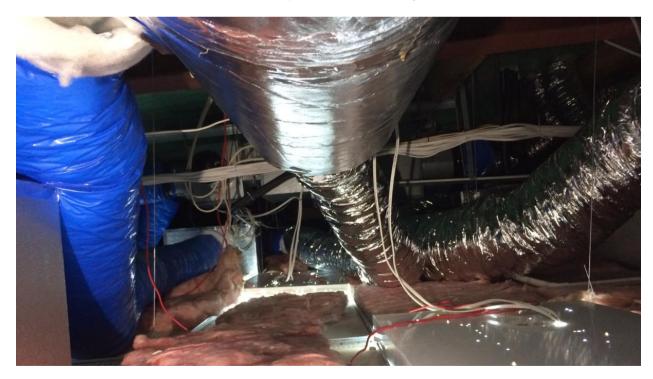
Redundant ducting and loose wiring can cause a fire hazard.

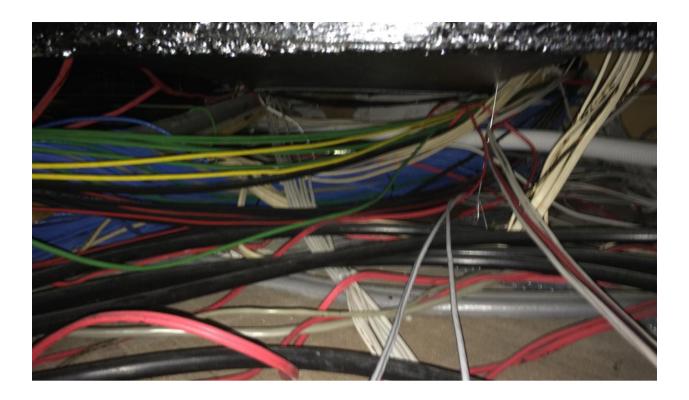
A lot of the existing wiring has not been secure as per the regulations. Power wiring is mixed and tangled with data, fire and communications cable.

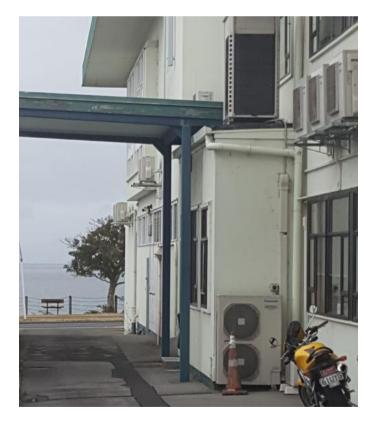
Ground Floor Outdoor Units

Many of the outdoor units have been installed in the vehicle lane at the rear of the building. The main issues are the ground level units could be damaged by vehicles using the lane. Other units have been installed at height to prevent damage from vehicle. This makes it hard for

maintenance and repairs EH&S process becomes very involved ie the lane has to be restricted, a platform may need to be used for access etc.
