Wednesday, 17 May 2017

I have carried out a visual building inspection on the Mangakino Bowling clubhouse, located on Moana Crescent, Mangakino.

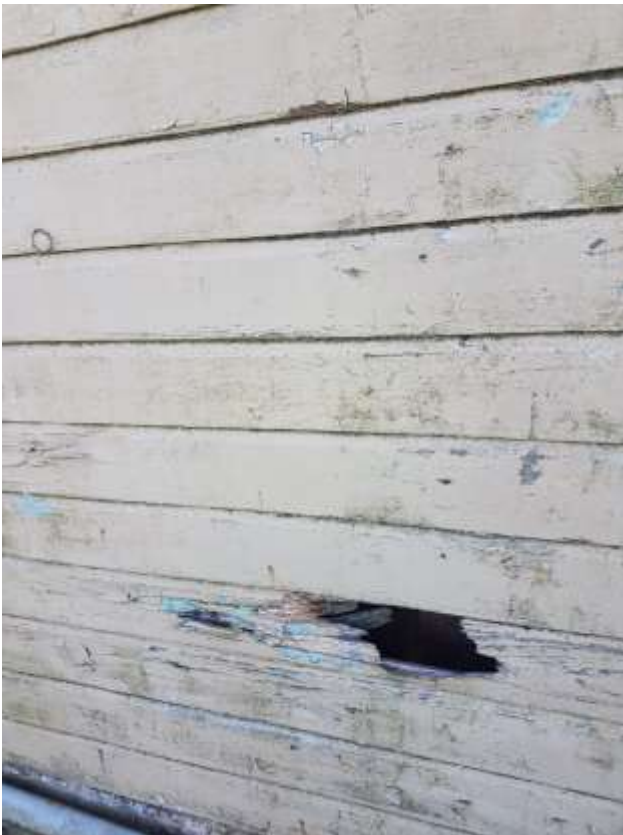
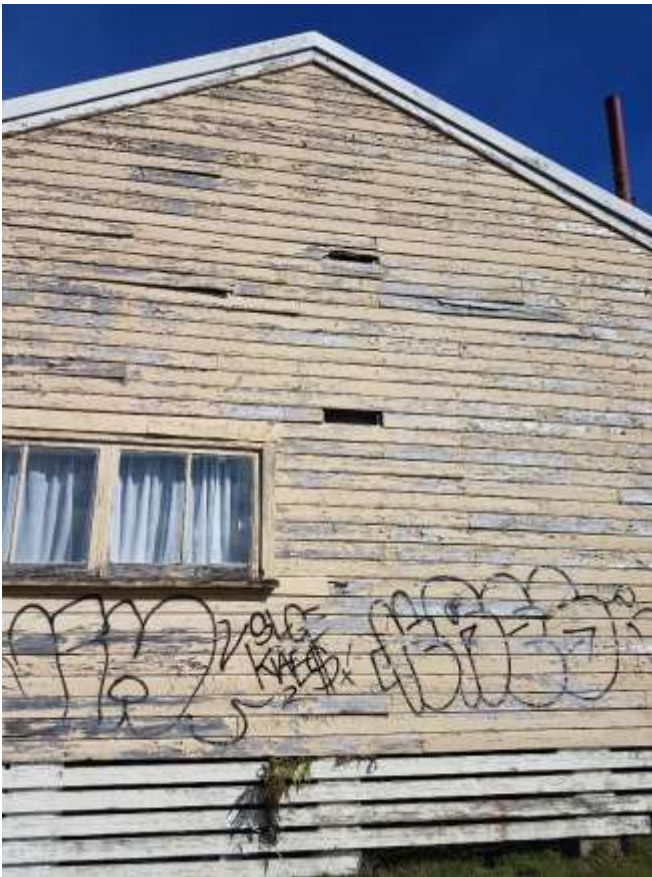
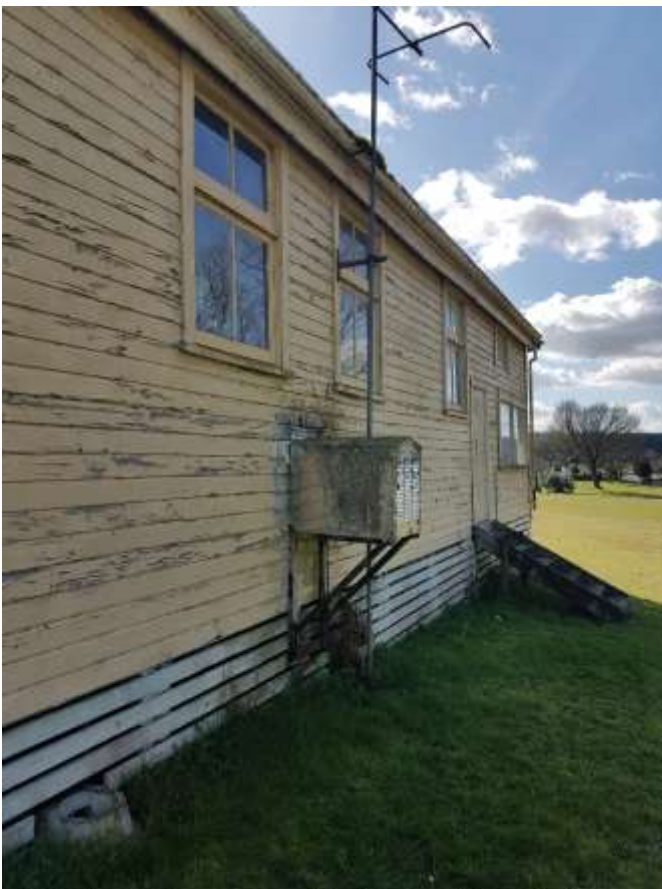
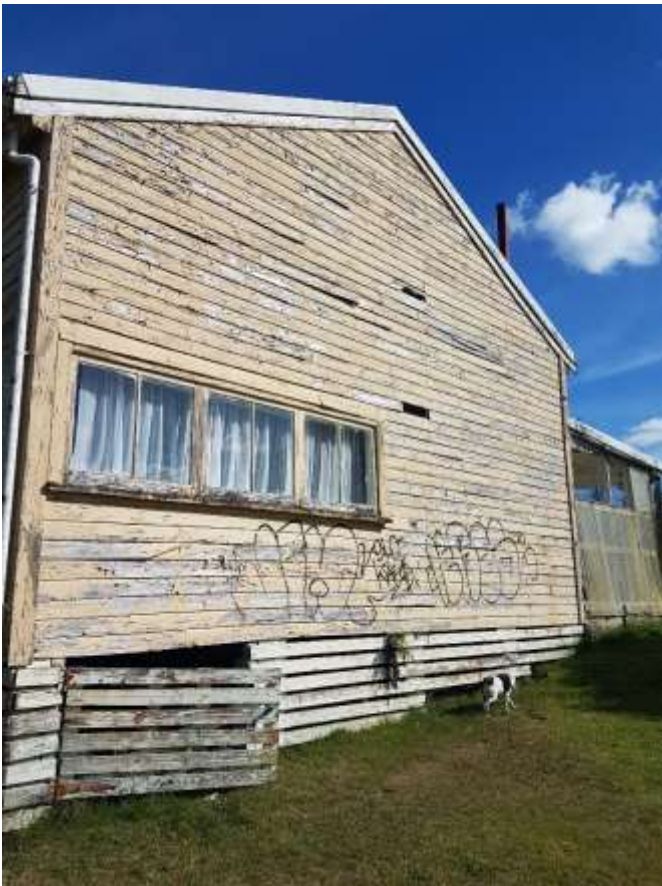
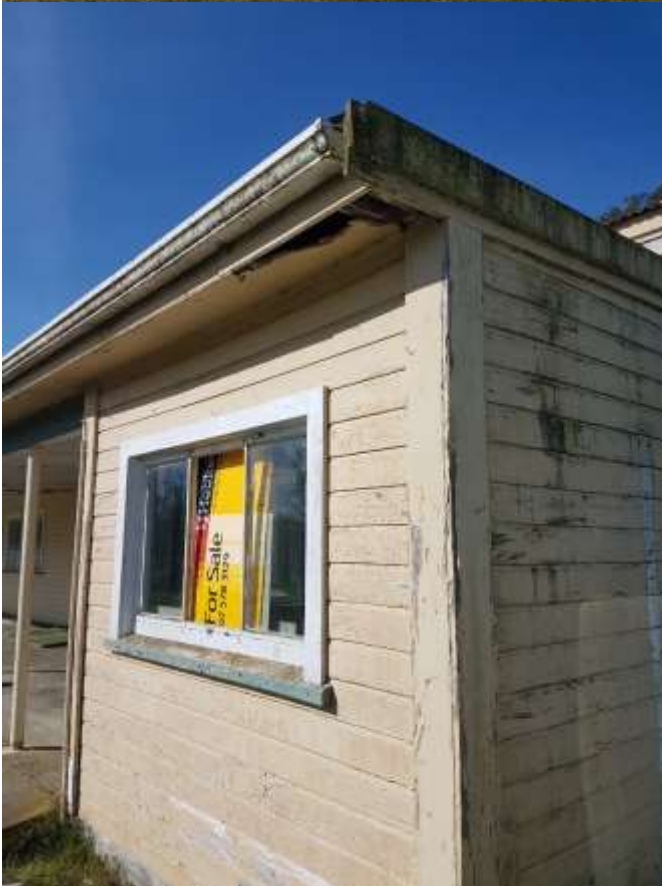
Exterior: The exterior cladding is in a very poor condition. There is the presence of rot, and decay to the cladding on just about every wall. The exterior has not been painted for many years, and there is the presence of borer in some of the bare timber areas. The wooden window joinery is also in a poor state of repair, and has not been painted for a considerable period.

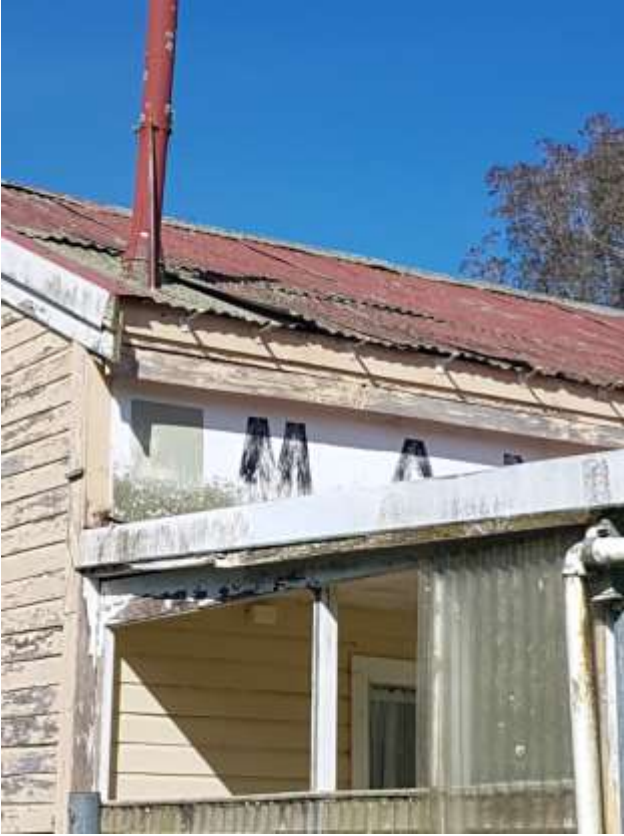
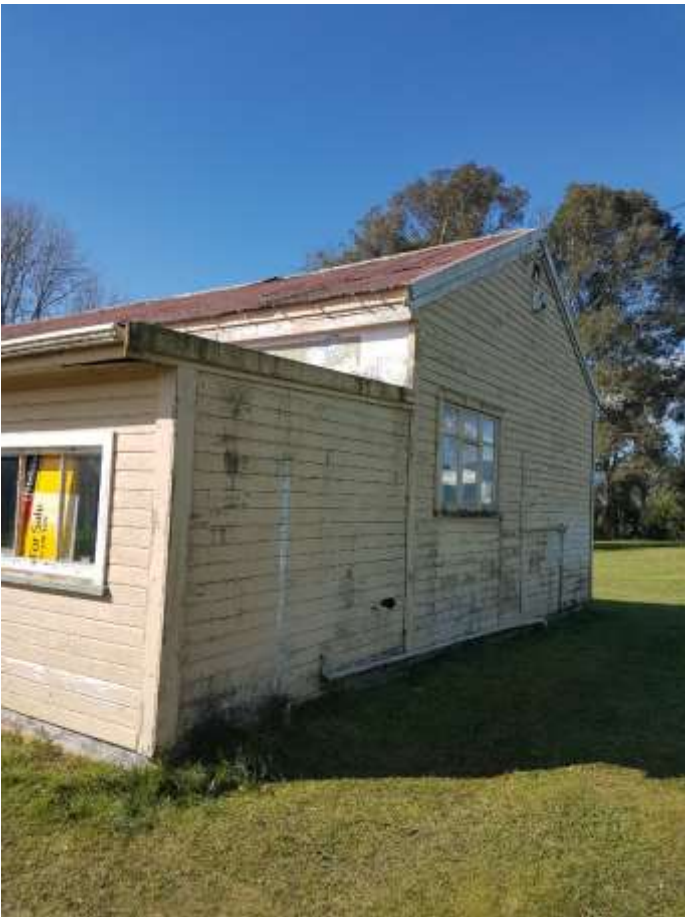
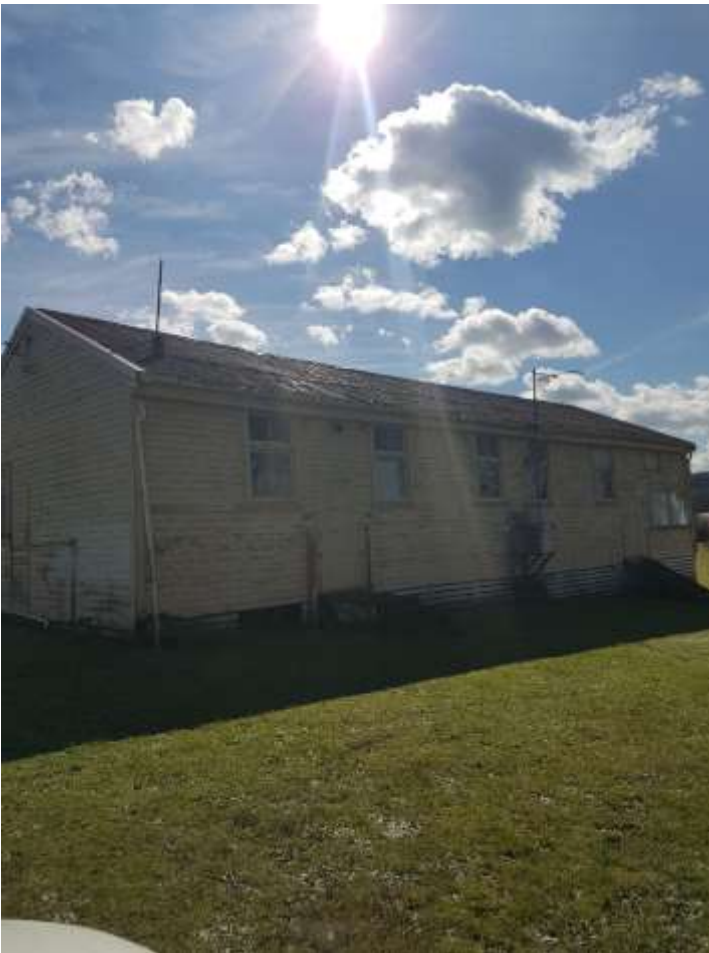
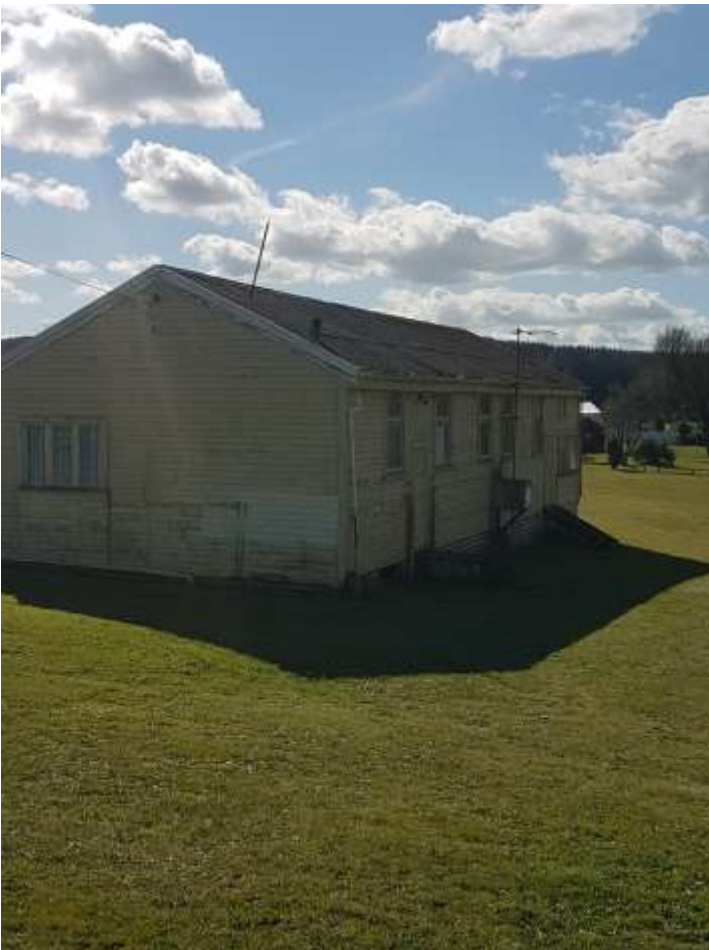
Roof: The roof is in a very poor state, and in need of replacement. It is lifting in several areas, as shown in the below pictures.

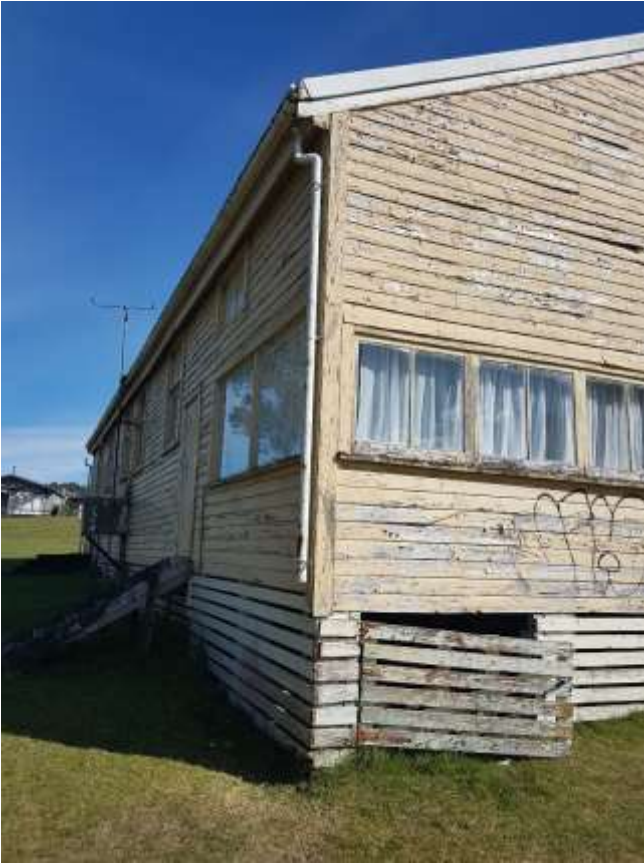
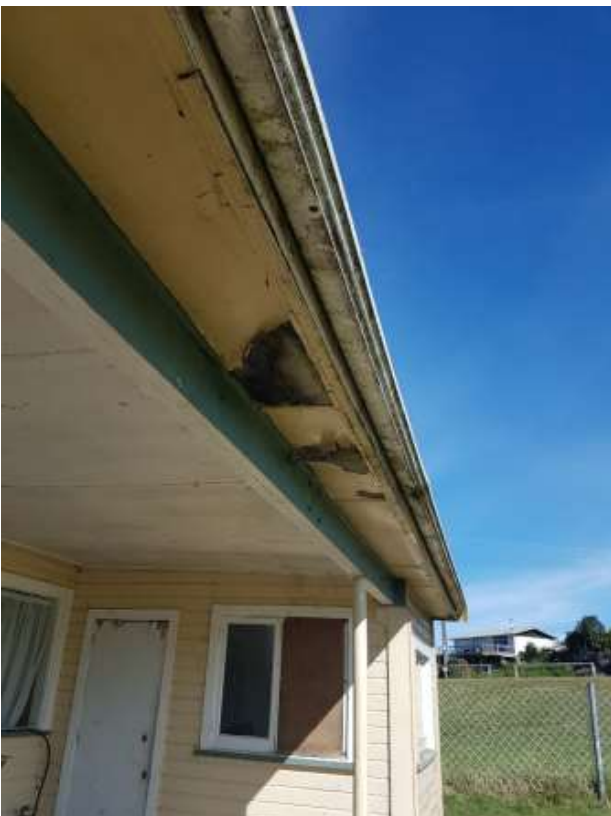
Spouting/Downpipes: Spouting is present on the back of the building, however it is full and growing grass. The spouting to the front of the main roof is non-existent. There is spouting on the verandah however this is in a poor state. The downpipes are all either broken or missing, and those that are present are not connected to any soakholes.

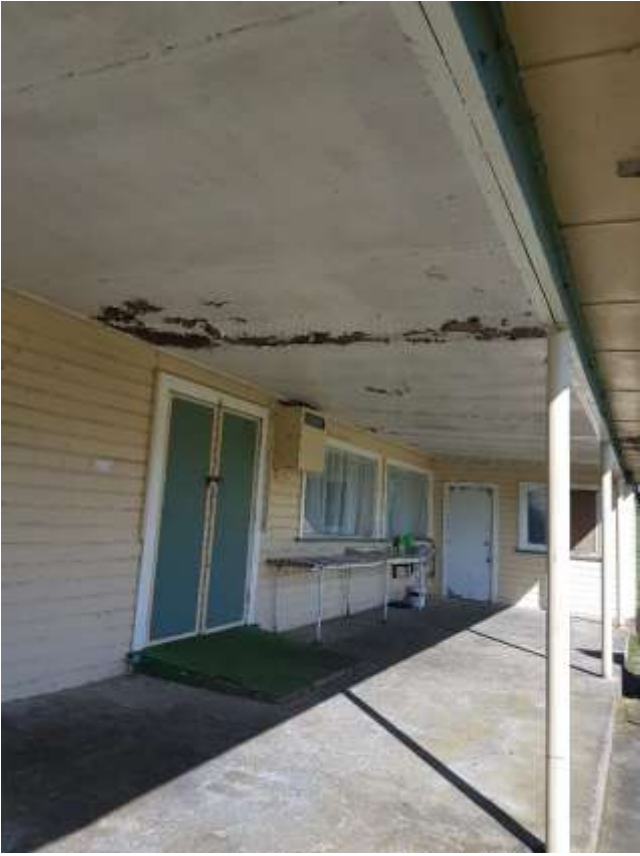
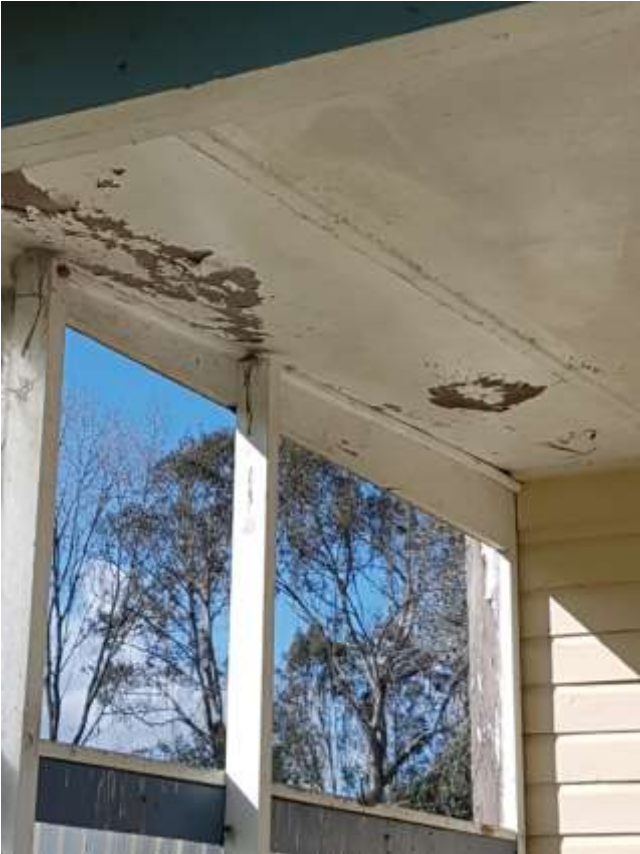
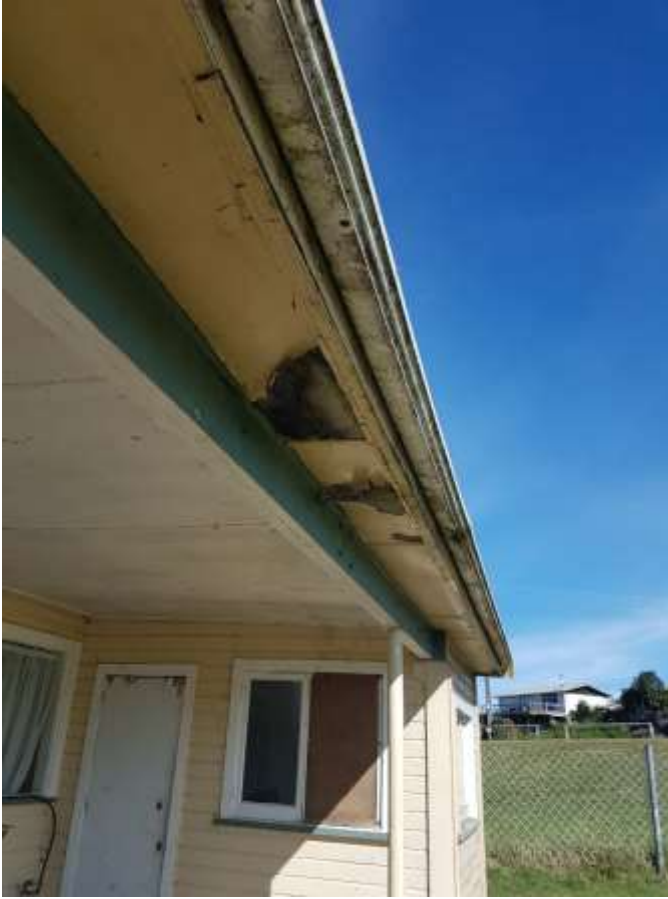
Soffits: The Soffits are in a poor condition, and in some areas sagging due to the roof leaking.

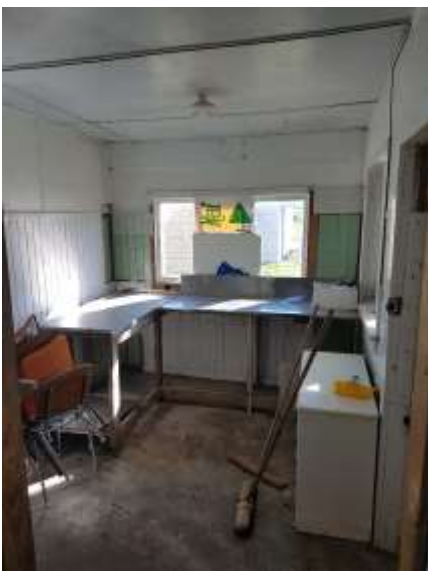
Foundations/Floor: The underside of the building is showing some signs of borer, and decay. It appears that there has been some settling in the corner of the building where the toilets are located. The building appears to be lower in that corner and this shows up by the door that leads into the toilet area binding on the floor when opened, however has a considerable gap beneath it when shut. The floor has a sizable water stain damage outside the Bar area which could have reduced the integrity of the floor itself. The floor coverings to the Kitchen area could possibly be an asbestos backed vinyl due to its age. There is an area next to the kitchen which has been partially de-constructed and in a state of dis-repair. Two of the windows in this area have broken panes of glass, and are temporary covered over.

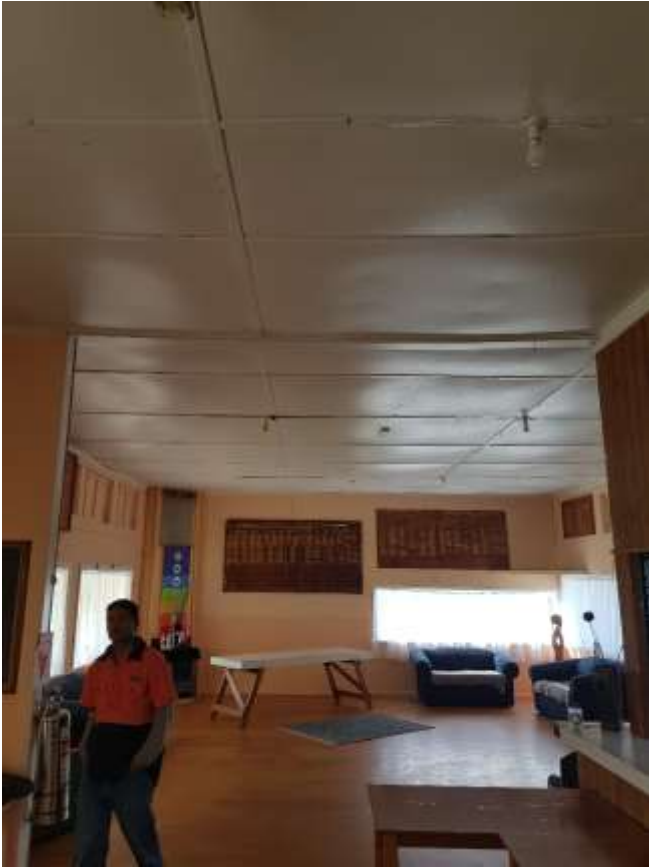
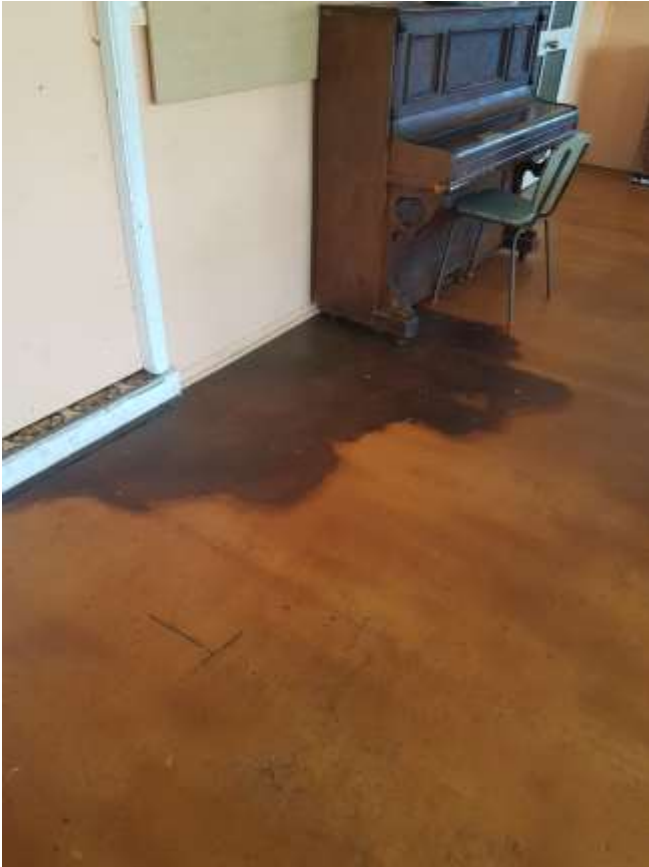
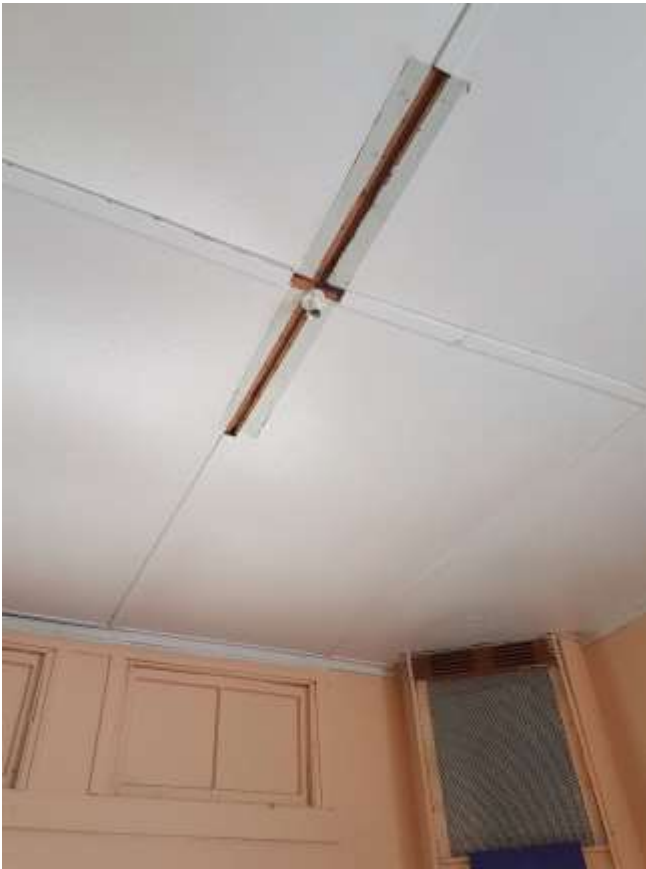
Interior: The Interior is in an average state. The ceilings have some considerable sagging and are missing some trim in several areas.

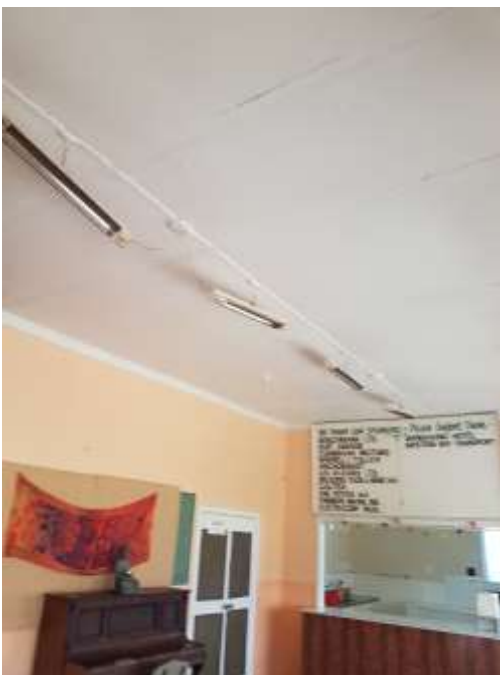
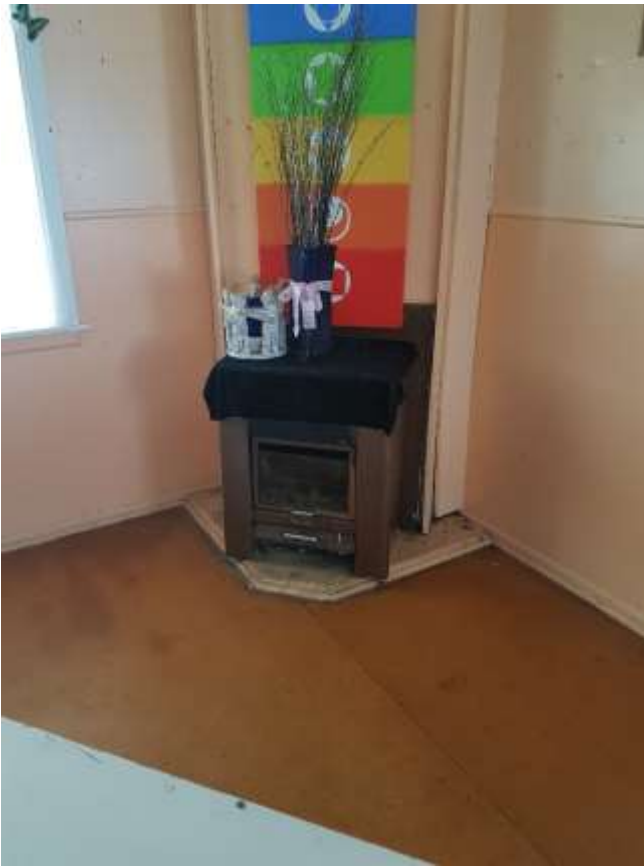
Heating: There is an old fireplace in one corner of the room, which I would suggest should not be lit without a qualified contractor inspecting its installation/safety. There does not appear to be the correct hearth used for the type of fireplace that is present. There appears to be ceiling mounted bar heaters at the other end of the clubrooms. Again I would suggest that these bar heaters be checked before use.

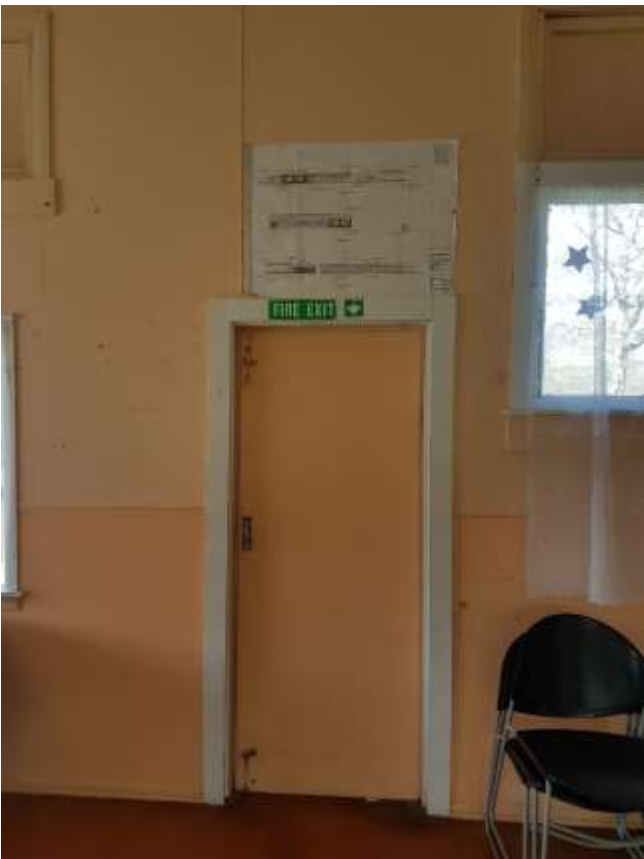
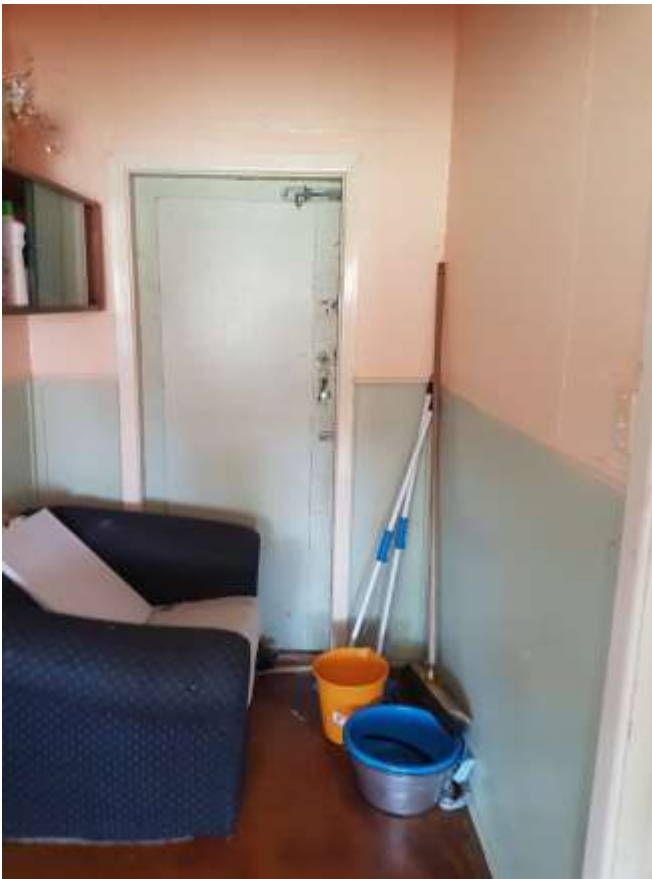
Emergency exits: The 2 sign posted Emergency exits are locked shut and do not have emergency crash bars. One of the doors has a pile of equipment in front of it.

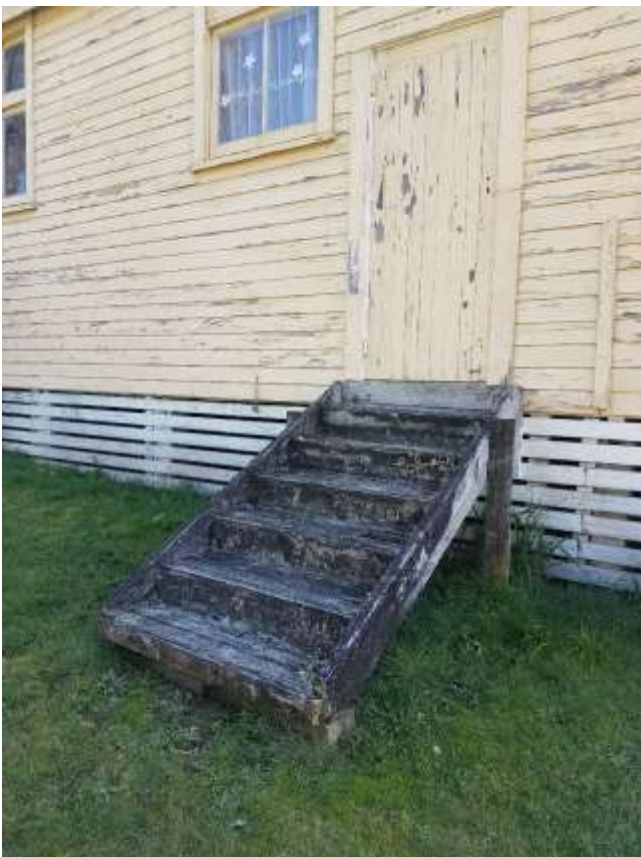
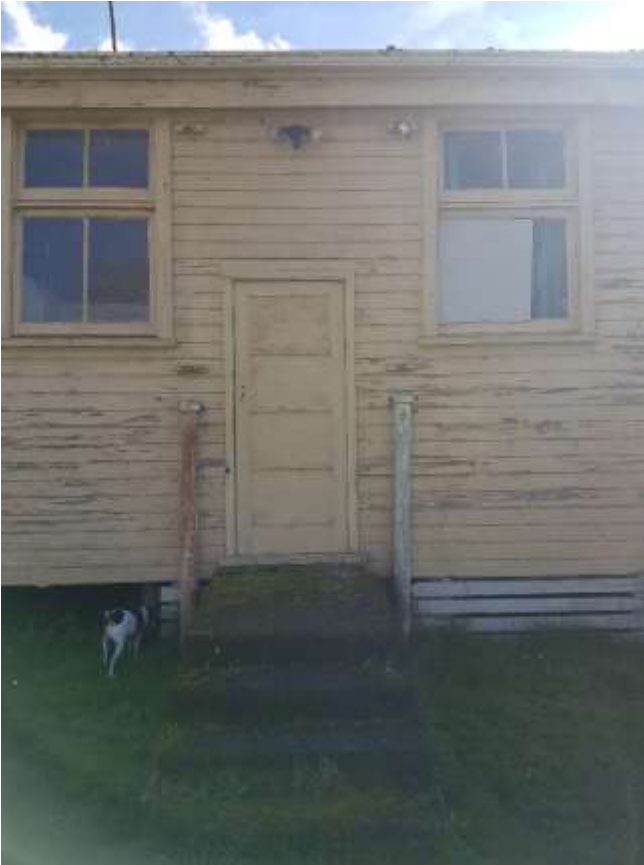
The Emergency exits lead out the back of the building down steps which do not have any handrails installed.

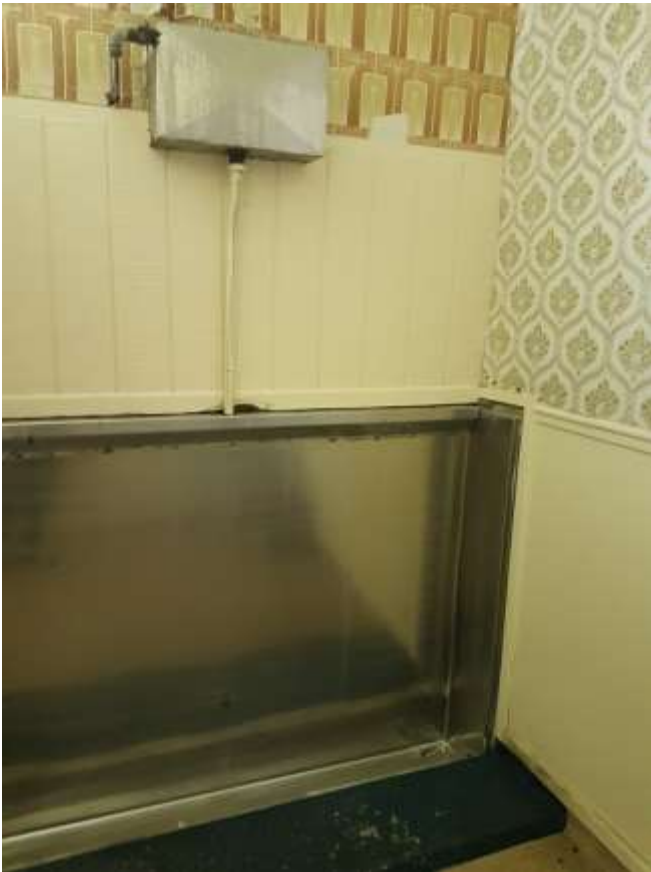
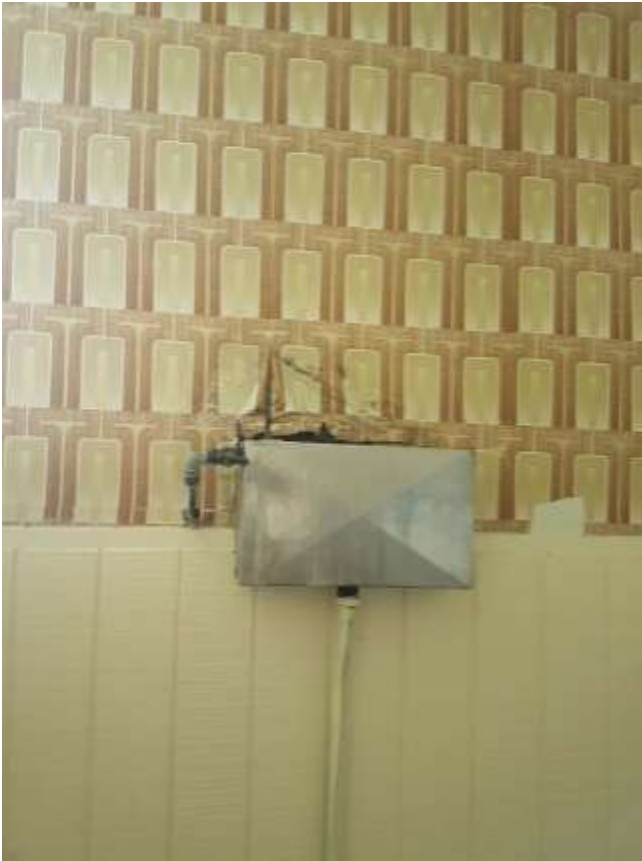
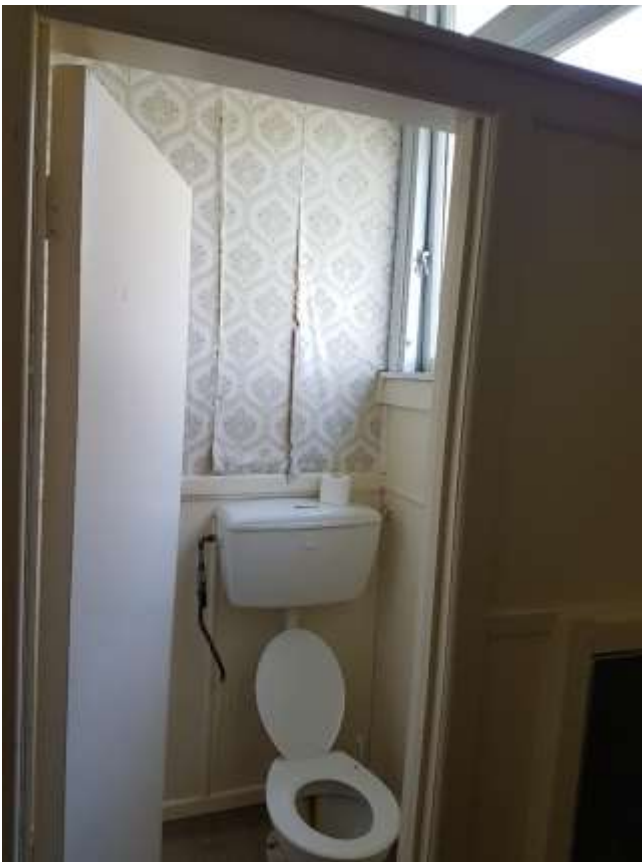
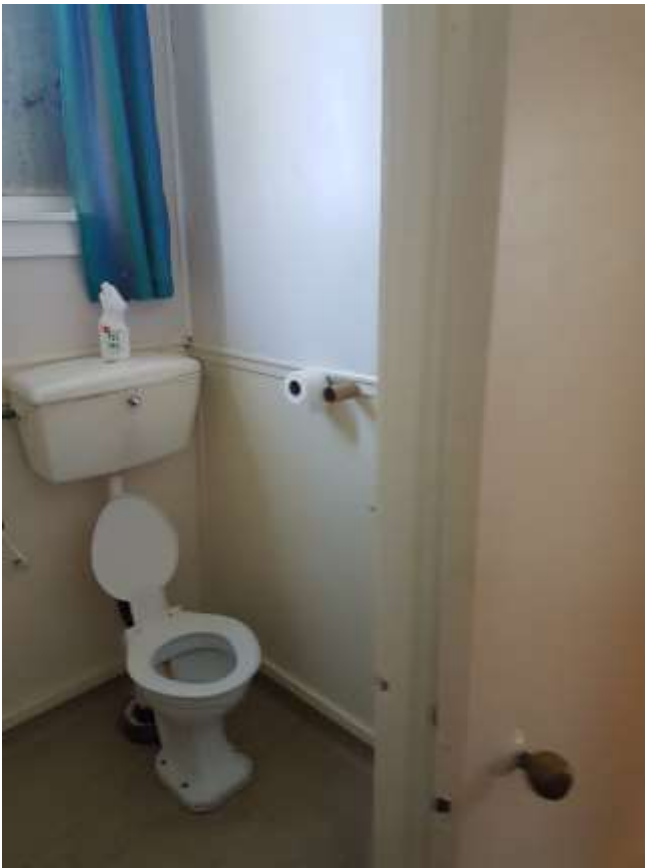
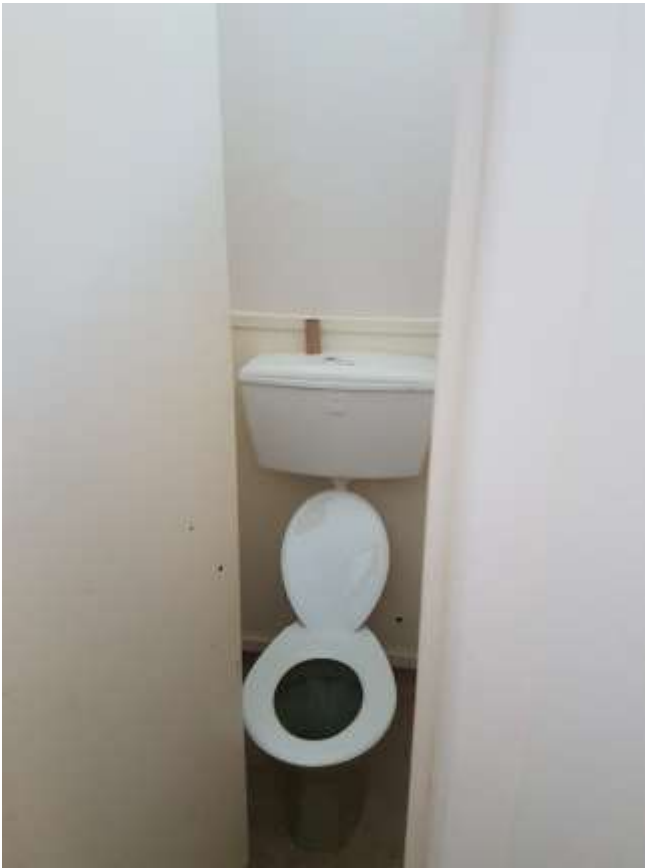
Toilets: The toilets are dated but tidy. However there is some rotten Gib board above the Urinal cistern, and wallpaper coming away in some areas.
