Extraordinary Council Meeting

13 April 2017

3.1	Inclusion of project in Annual Plan 2017/18 - Proposed changes to the Taupo District Council Lake Terrace Building	
Attachment 1	Clearsafe Environmental Solutions Certificate of Analysis	3
Attachment 2	Clearsafe Environmental Solutions Asbestos Register Report	7
Attachment 3	Ward Demolition email re Asbestos Register Report	18
Attachment 4	BECA Seismic Assessment Report.....	20
Attachment 5	Cheal Consultants Structural Engineers Seismic Strengthening Preliminary Assessment	110
Attachment 6	AHI Carrier (NZ) Ltd HVAC and Ceiling Space Report	114
Attachment 7	Site assessment	121
Attachment 8	Map 1 - Site assessment locations	123

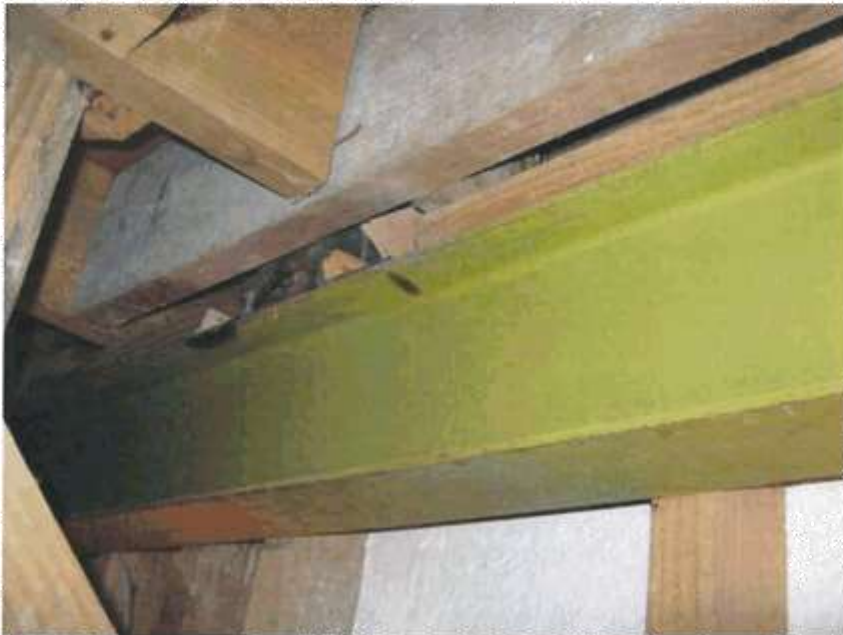
Sliding Stair Connection

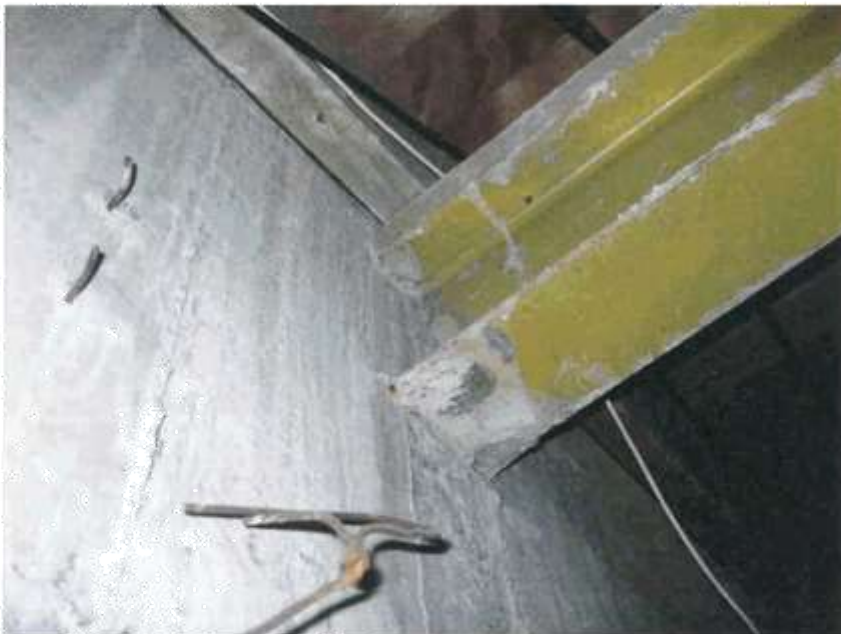
Strongroom at First Floor - Embedded Steel Beam

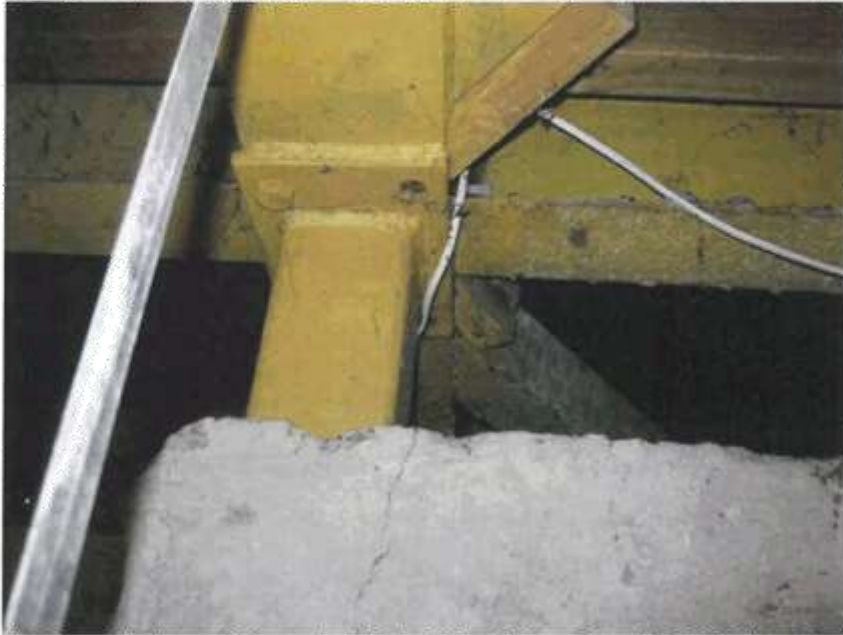
Top of Strongroom

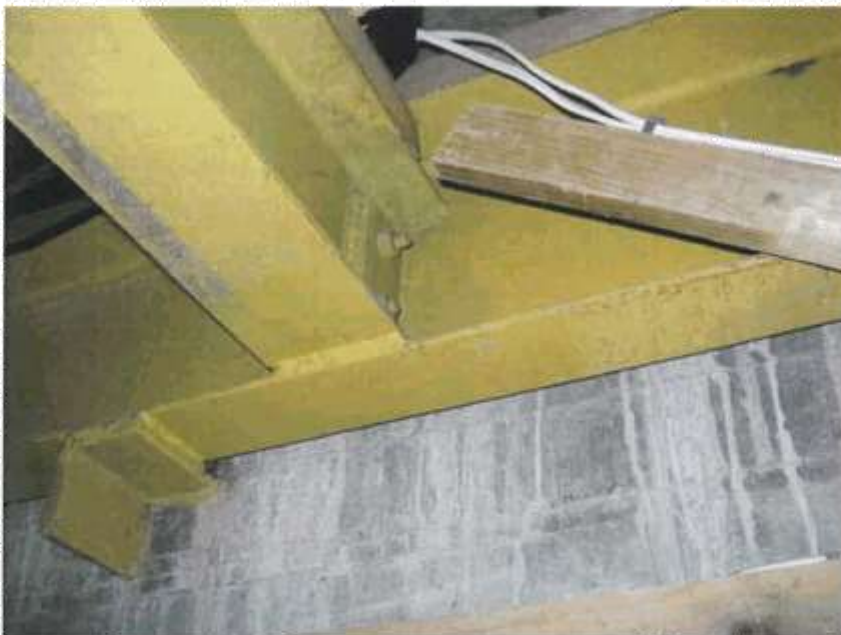
Typical Roof to Wall Connection

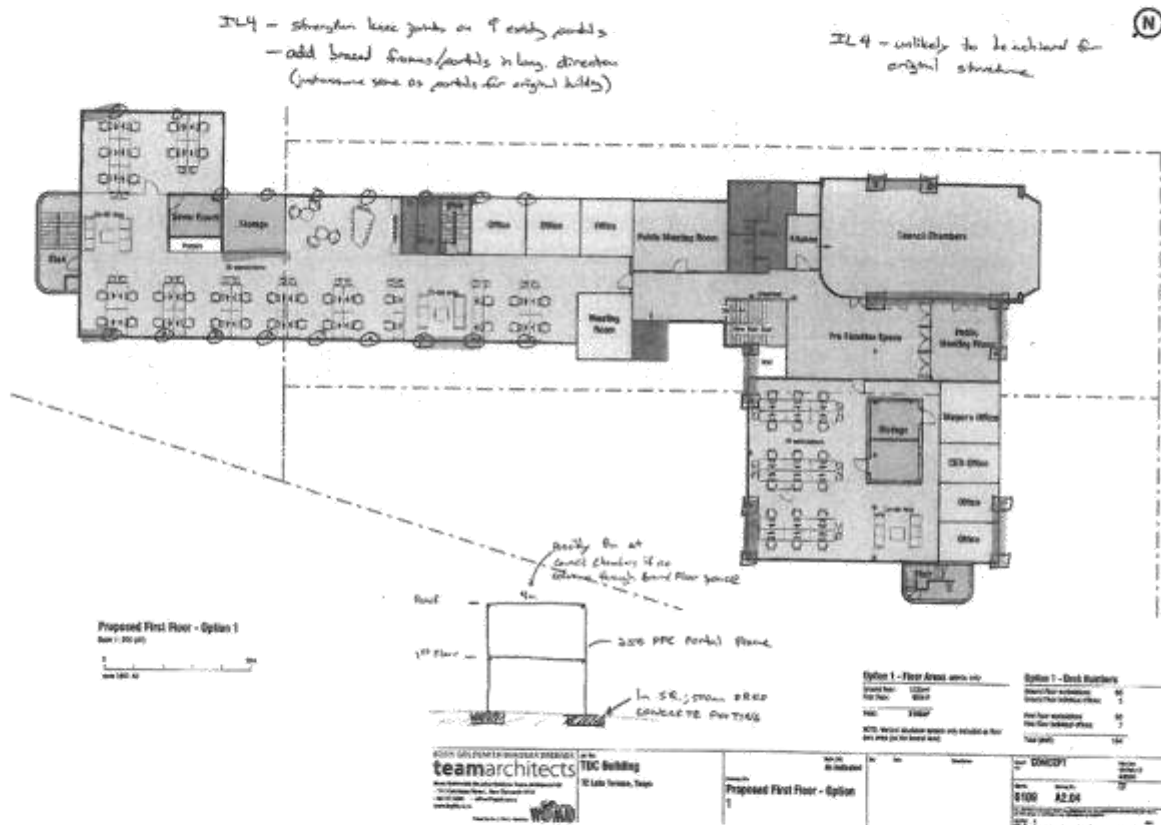
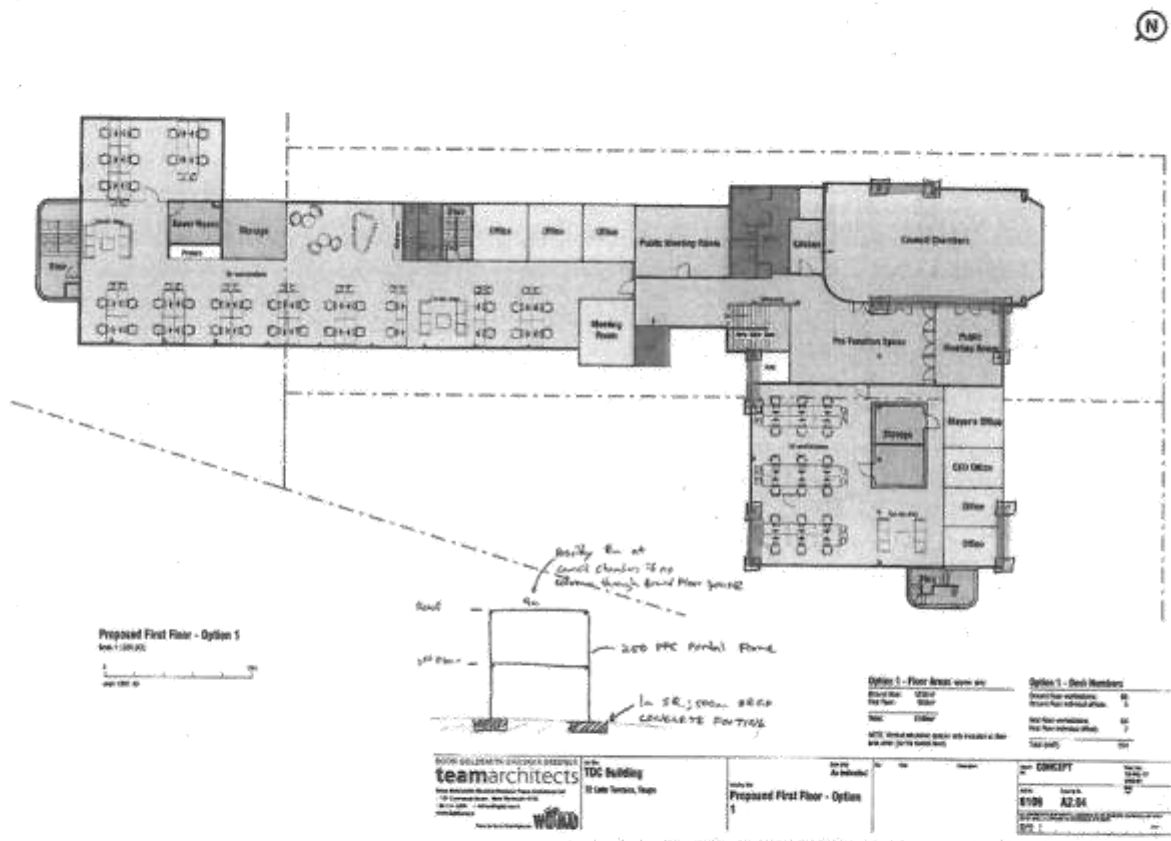
1. Strengthening Mark-up for IL2
2. Strengthening Mark-up for IL4

The proposed strengthening required to bring the original structure up to at least 67%NBS consists of 6 steel portal frames placed strategically throughout the structure and primarily along the perimeter of the building. These portals would need to be double portals to strengthen both floors. Alternatively, a braced frame system could be used but the impact on the use of the structure and the overall cost would be similar. These works would result in fairly extensive secondary works to remove and repair floors, walls, ceilings, and linings and provide connections as required from floor joists, beams and bearers. The portals would also require separate concrete pad footings. A mark-up of the building is attached with indicative portal locations and sizes for strengthening to 67%NBS for an IL2 structure.

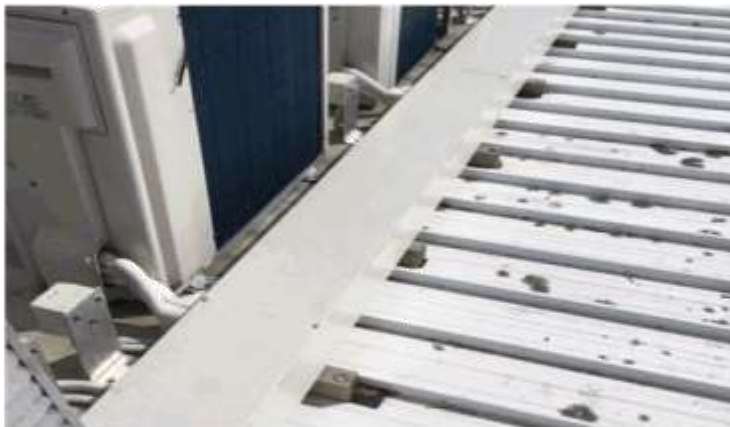
The Panasonic outdoor units have been installed on the roof on timber frames. The anchor bolts through the roof have started to wear and the roof is leaking water to the ceiling below. A better solution is to install all the outdoor units on Monkey Toe mounts.

All outdoor units should be installed on Monkey Toe roof brackets removing the wooden mounts. This will help reduce the deterioration of the roof and reduce the possibilities of water leaks.

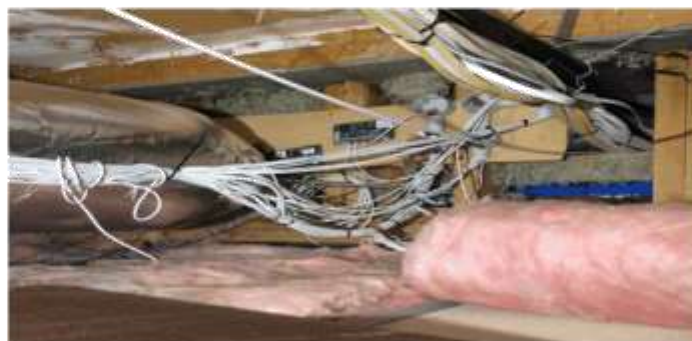
The current ceiling spaces on the ground and top floor are quite congested with ducting, data cables and power cables. Some of the air conditioning ducting and insulation is redundant and should be removed. The electrical wiring should also be assessed as some of the cables not used have power connected to them.

Once completed the insulation should be replaced and installed correctly on the tiles to provide the required level of insulation. This will reduce the energy losses in heating and cooling and reduce the electrical energy losses as the air conditioning equipment will be operating on a reduced capacity.

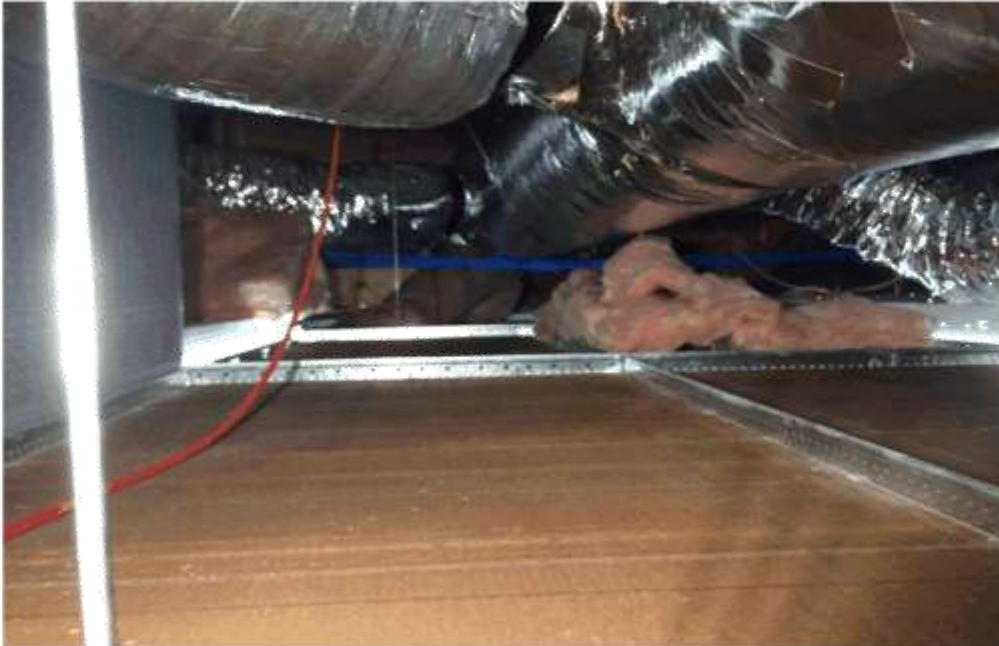
The insulation has been removed in mainly parts of the ceiling tiles.

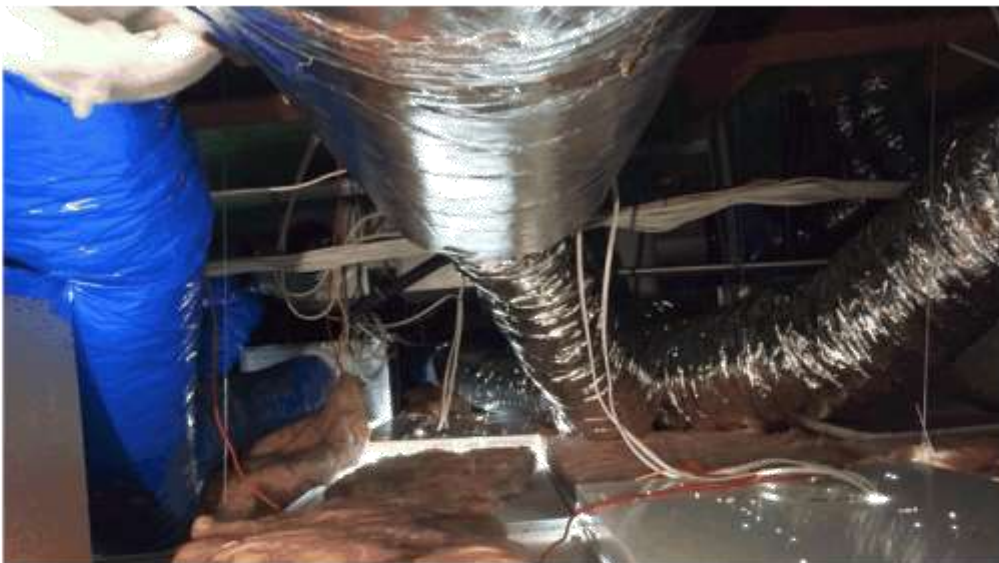
Redundant ducting and loose wiring can cause a fire hazard.

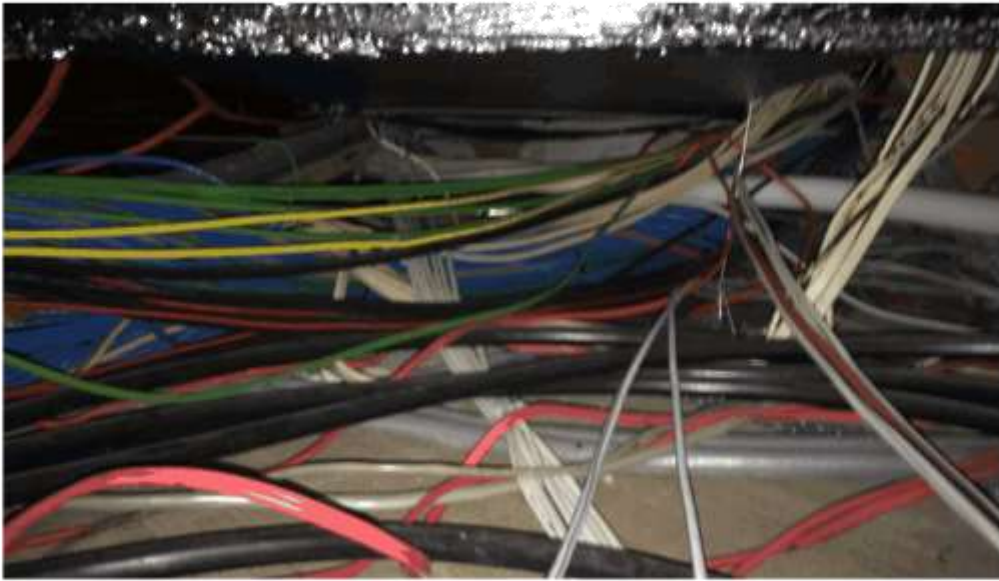
A lot of the existing wiring has not been secure as per the regulations. Power wiring is mixed and tangled with data, fire and communications cable.

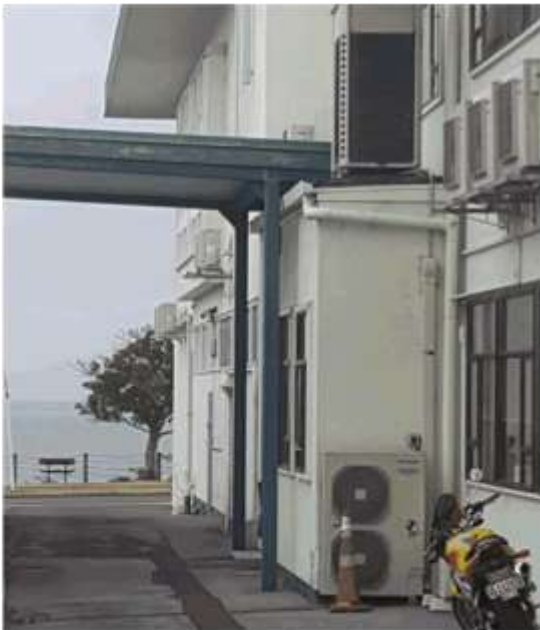
Ground Floor Outdoor Units

Many of the outdoor units have been installed in the vehicle lane at the rear of the building. The main issues are the ground level units could be damaged by vehicles using the lane. Other units have been installed at height to prevent damage from vehicle. This makes it hard for

maintenance and repairs EH&S process becomes very involved ie the lane has to be restricted, a platform may need to be used for access etc.
