OUR REF 17100L1

28 March 2017

## 72 LAKE TERRACE, TAUPO : SEISMIC STRENGTHENING PRELIMINARY ASSESSMENT

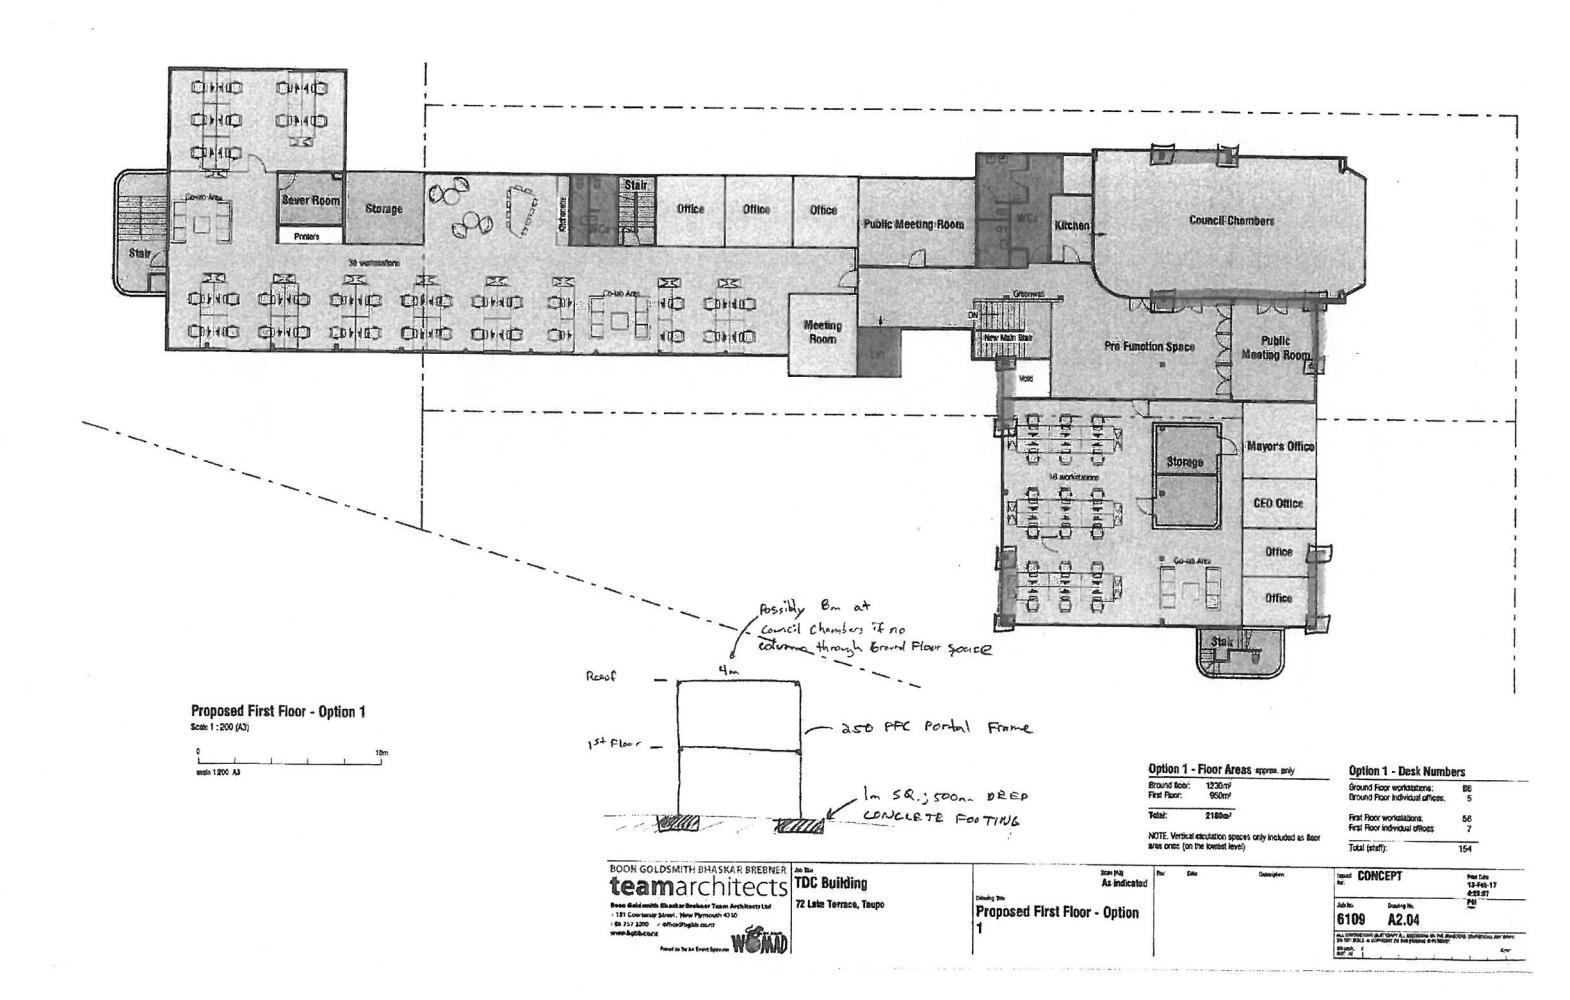
2. Strengthening Mark-up for IL4

Should Council require the building(s) to be rated as IL4 structures, strengthening to all structures would almost certainly be required as this has a significant effect on the %NBS – approximately half of the IL2 score. The strengthening proposed above for an IL2 structure would not be sufficient to bring this building up

above the 67% threshold desired by Council. Further strengthening would almost certainly be cost prohibitive and may prove to be physically impractical due to the extensive works required.

The other more recent structures and additions would likely need to be strengthened as shown on the attached mark-up for IL4 structures. This may include strengthening of the knee joints of 9 existing portals in the transverse direction and the construction of 4 or 5 new portal frames in the longitudinal direction. Again, since individual assessments of the further additions has not been completed, the extent of strengthening required for each individual structure/addition may vary pending a more detailed analysis.

In summary, should IL4 be desired, a new structure is recommended—certainly for the older, original structure but also for the subsequent additions. The resulting performance of a new structure will be much greater than a retrofitted/strengthened older structure and will perform as an integrated system rather than a patchwork of various systems. In addition, the cost of strengthening (in terms of dollars and time) is likely to be marginally cheaper, if at all, and will still result in a reduced capacity structure when compared to new. In the case, of the original building. It is unlikely to be feasible to achieve an IL4 structure at 67%NBS, regardless of strengthening.
