**Ordinary Taupō Reserves & Roading
Committee Meeting**

2 March 2023

Appendix 1 – Council Tree Assessment Checklist (SR#: 2113317)

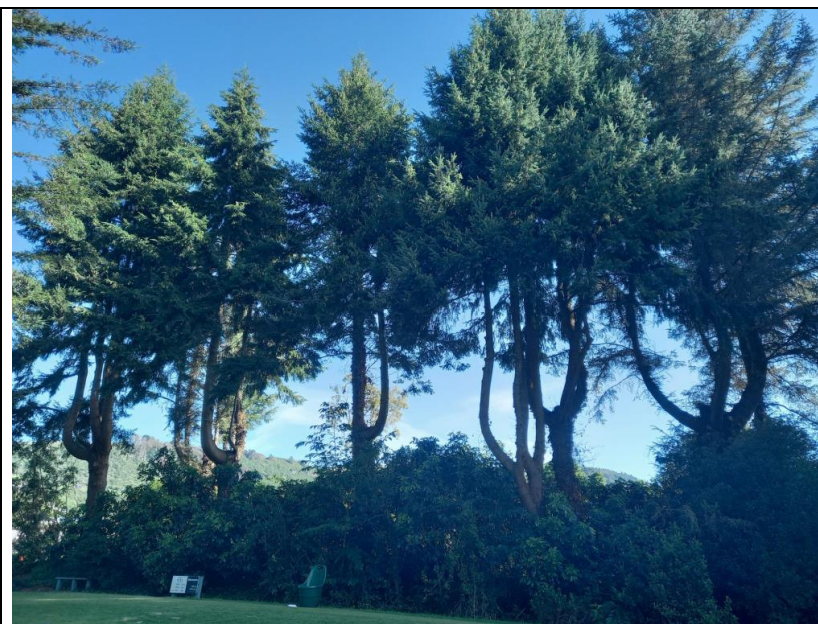
- The trees have some significance on the landscape due to their size but there are other mature trees in the near vicinity of much better form, that haven't been topped in the way that the Douglas Firs have.

- 4.5 General comment:
- I believe in this case that the customer's complaint has merit, although difficult to suggest it relates to extreme hardship. The trees being a tall evergreen shelter belt right along the northern side of their property. The trees have been historically topped. The topping was evidently carried out years ago and the trees seem to have adapted and grown on they are still somewhat compromised. As the golf club also would be supportive of tree removal in my opinion in this case I believe it can be justified provided that replacement planting is carried out. There is not really any satisfactory pruning option that would provide a long-term resolution. Either deciduous species and / or low growing evergreen shrubs that will form a screen between the tee and the property

Trees viewed from Golf tee

- 4 **Proposed Action**
- 4.1 What species of tree is a suitable replacement?
- Lower growing tree to encourage bird life while not repeating shade issues [eg. Kowhai]. Alternatively low growing deciduous species to provide autumn colour, while again not shading.

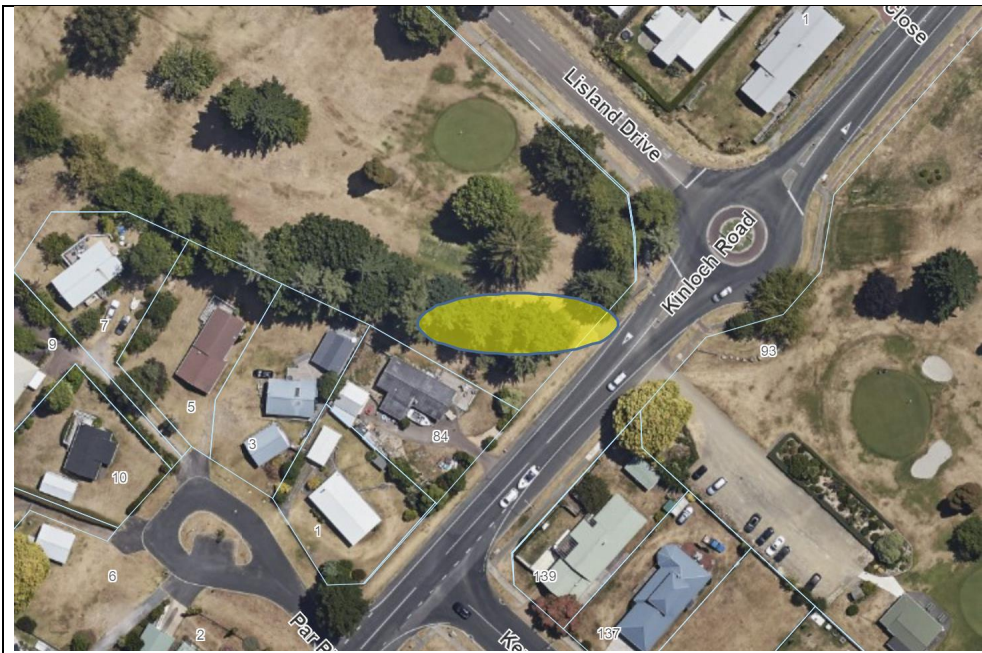
Location of Douglas Fir Shelter Belt
