# KINLOCH LAKE FRONT RESERVES

EASTERN RESERVE  
KINLOCH ESPLANADE

ACTION GROUP SUBMISSION

# KINLOCH EASTERN RESERVE :

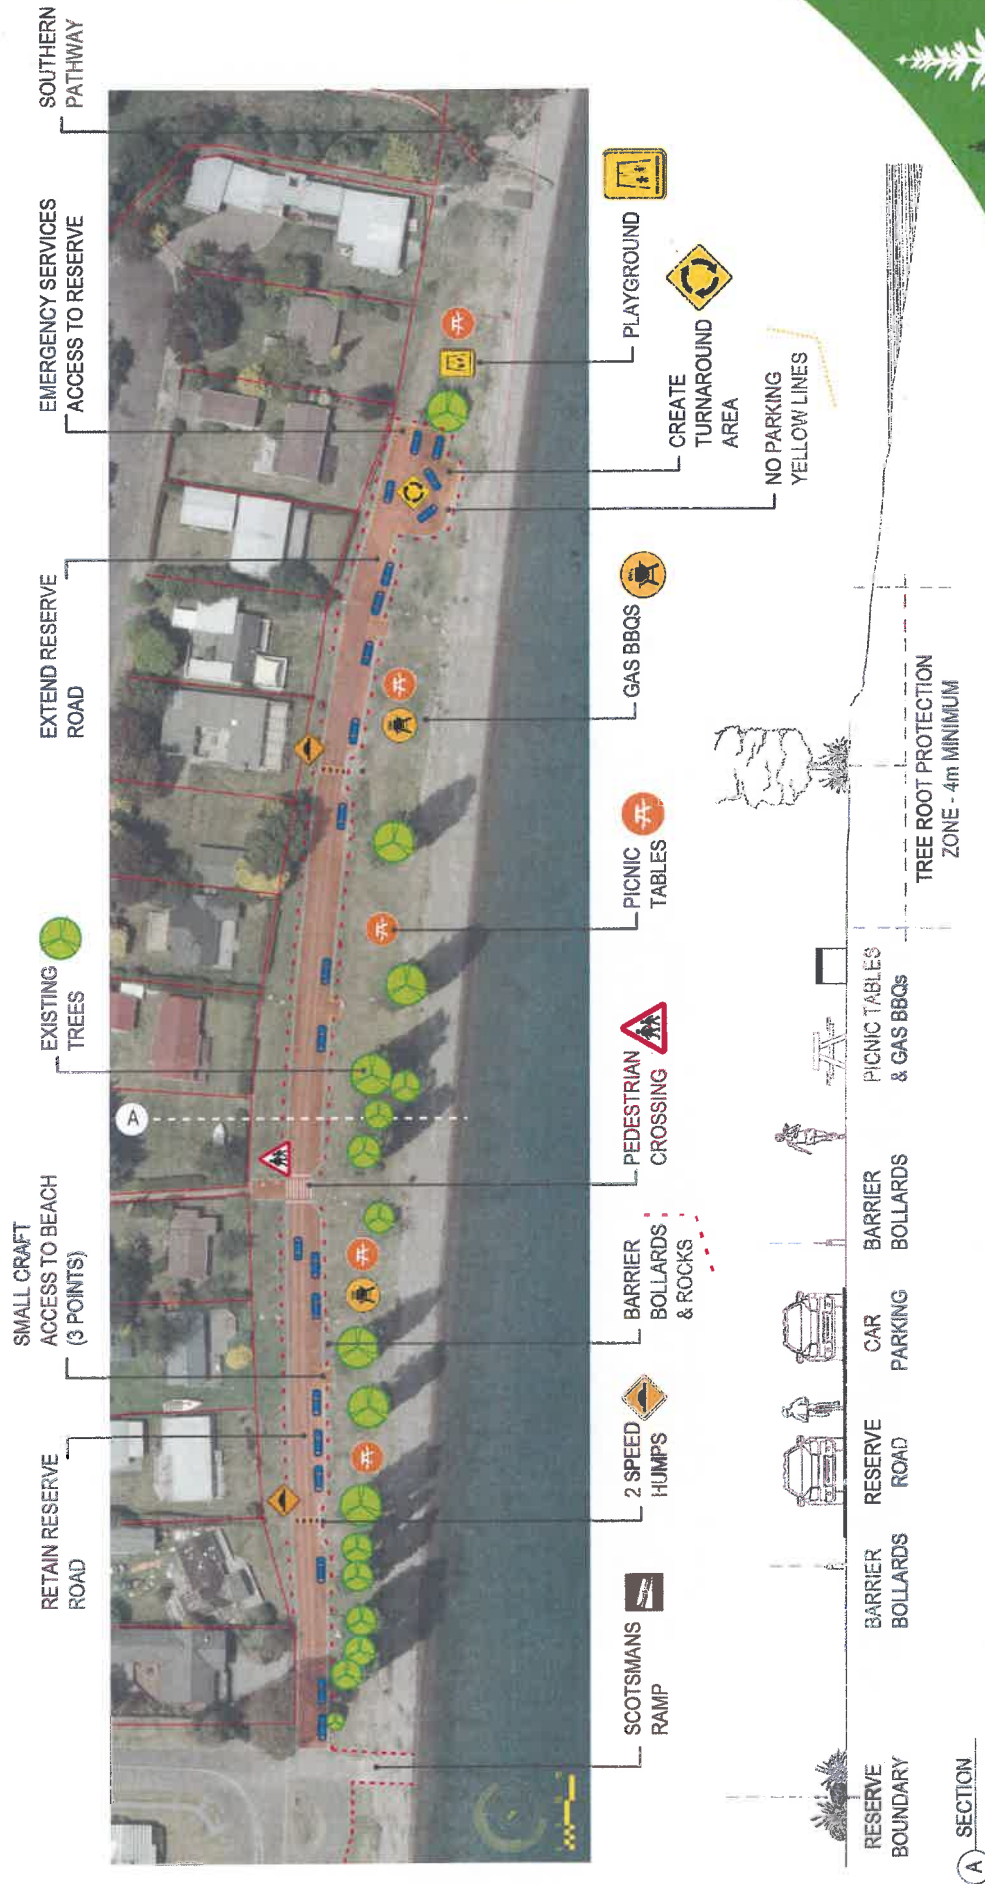
Kinloch Reserve

COMMUNITY DRAFT DESIGN FOR CONSULTATION: 07 FEB 2017

## KEY DESIGN POINTS:

- RESERVE PROTECTED FROM EROSION
- NOTABLE TREES PROTECTED FROM CARS
- 1 PEDESTRIAN CROSSING
- 2 RAISED SPEED HUMPS
- 20 CARS SPACES (APPROX)
- 1 TURNING CIRCLE
- PLAYGROUND AND PICNIC/BBQ AMENITIES

Parking would be limited to approximately 20 vehicles. Large trailers, campervans and trucks would be discouraged from entering the reserve through signage and the size of the turning circle.

Traffic would be calmed by the installation of three judder bars, one of which would be for pedestrian access from Keitha Place.

Bollards, rocks or other forms of barrier would keep cars off the grassed areas and the required distance away from the existing notable trees. Gaps would be created in the barrier so that Keitha Place and other nearby residents could walk small water craft across the reserve to the beach.

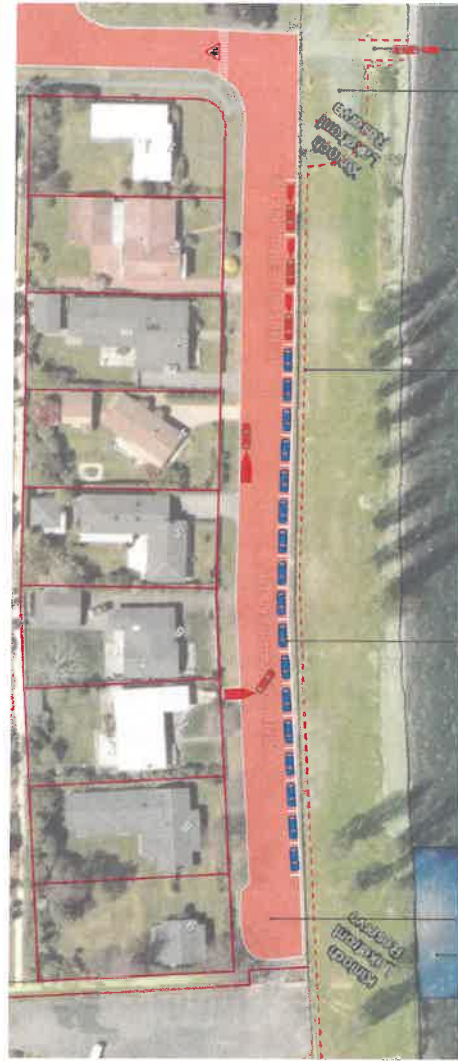
# KINLOCH ESPLANADE:

COMMUNITY DRAFT DESIGN FOR CONSULTATION: 07 FEB 2017

- KEY DESIGN POINTS:**
- 17 PARALLEL CAR PARKS ON ESPLANADE
  - 3 CAR & TRAILER PARKS ON ESPLANADE NEAR SCOTSMANS RAMP
  - PEDESTRIAN CROSSING ON MARINA TERRACE
  - ADEQUATE SPACE FOR RESIDENTS ENTERING & EXITING DRIVEWAY WITH BOAT TRAILERS
  - ROCKS REMOVED NEXT TO SH LANE

**17 CAR PARKS**

**3 CAR & TRAILER PARKS**

**SCOTSMANS RAMP**

Three parallel car and trailer parks be designated stretching from the entrance of the Scotsman's ramp along the Esplanade.

Remainder of parking to stay as parallel parking. (Open to review at a later time)

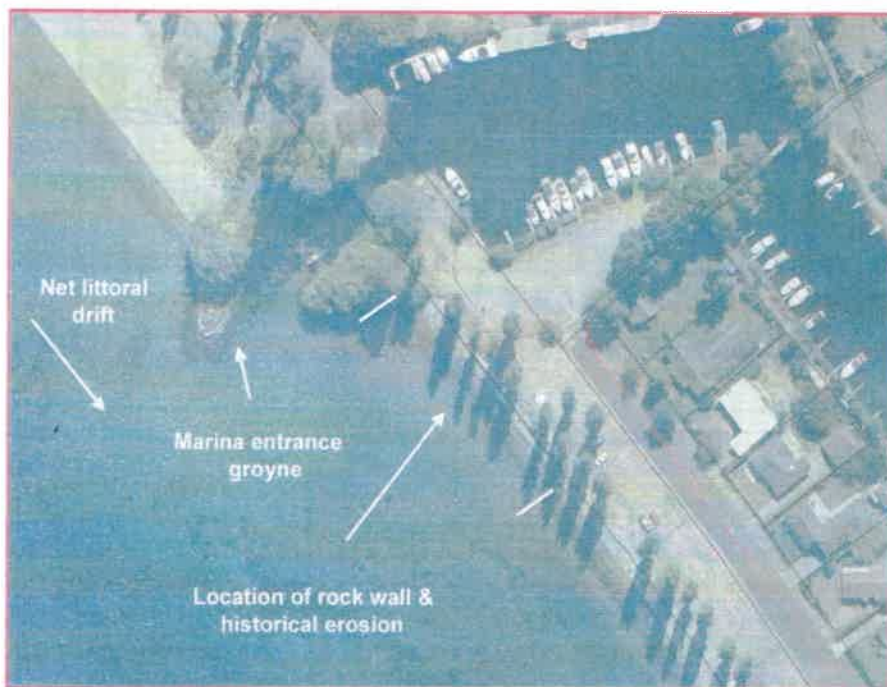
Photo 7. Kinloch shoreline, [2003]

At Kinloch, the area of erosion is relatively confined to the downdrift side of the marina leeward breakwater. The main items at risk are approximately 4-5 poplars and the reserve area itself. A reasonable buffer still exists before the road and houses. Services such as water and sewer are also well clear of the area at risk.

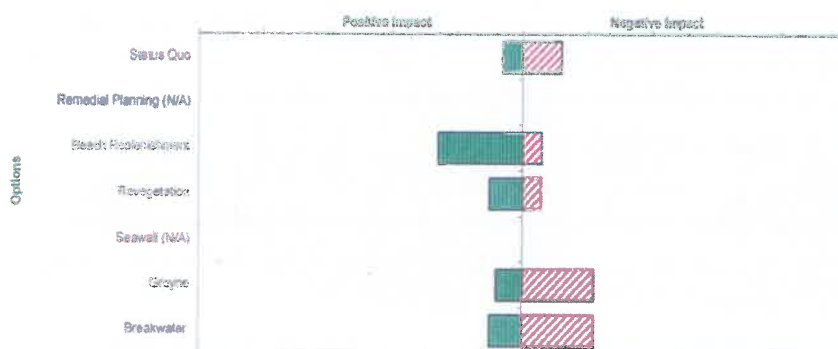
WHANGAMATA BAY/KINLOCH –  
QUALITATIVE ANALYSIS SUMMARY

The graph below shows, in summary form, the results of the qualitative matrix for Whangamata Bay. Non structural options were not considered applicable in this management area based on the current level of erosion and because a reasonable buffer already exists. The results show that the soft structural options have the greatest positive impacts with the least negative impacts. A seawall exists so hasn't been specifically assessed, options for enhancing the wall are discussed further below. The other hard options have the greatest level of negative impact with only minimal positive impact. The status quo option has a moderate level of negative impact relative to the other options and has the least positive impacts of the options available.

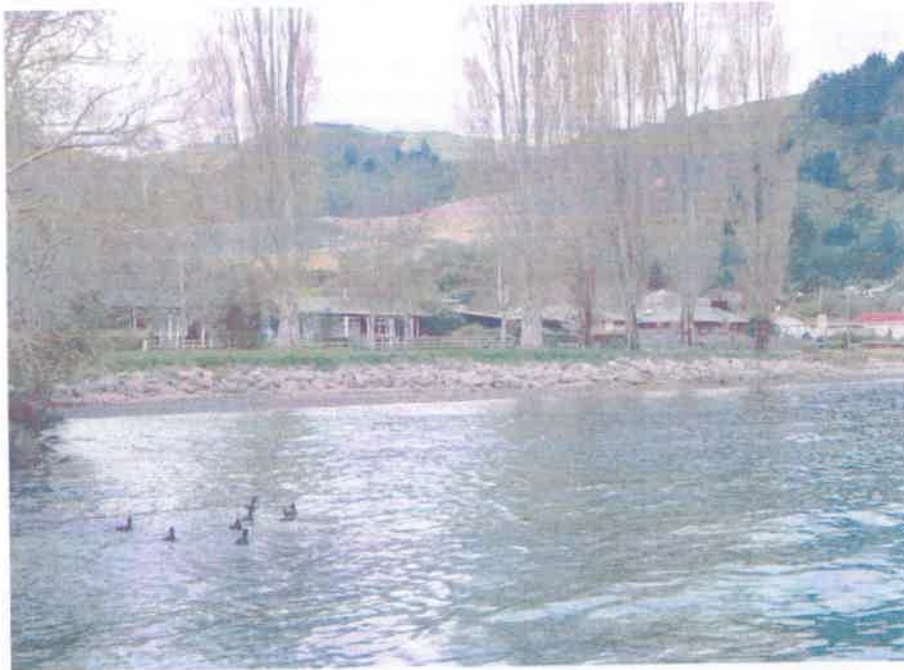
Photo 8. Kinloch rock wall, August 2005

The situation at Kinloch is one of a post implementation phase of the installation of a rock seawall in response to erosion events in 2004. As part of the expansion of the marina there were also plans to carryout beach nourishment in front of the revetment creating a buried seawall. This process was held up due to getting approvals for the nourishment. The result is that the wall has assisted in stabilising the erosion area, however the character of the beach and access has been affected. Secondary or localised erosion/scour has also occurred at the end of this rockwall structure (i.e. 'end effects').

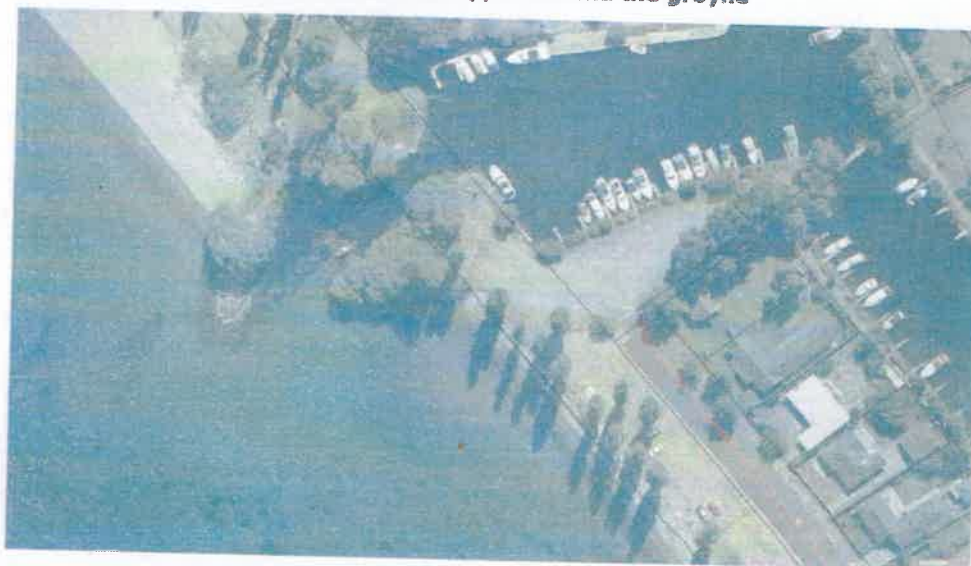
**Kinloch marina showing sediment trapped behind the groyne**

The overriding cause of erosion in this compartment is considered to be the marina groyne impeding the eastward littoral drift of sediment. The groyne is also responsible for the partial loss of sediment out into deeper water.
