Extraordinary Council Meeting

13 April 2017

3.1	Inclusion of project in Annual Plan 2017/18 - Proposed changes to the Taupo District Council Lake Terrace Building	
Attachment 1	Clearsafe Environmental Solutions Certificate of Analysis	3
Attachment 2	Clearsafe Environmental Solutions Asbestos Register Report	7
Attachment 3	Ward Demolition email re Asbestos Register Report	18
Attachment 4	BECA Seismic Assessment Report.....	20
Attachment 5	Cheal Consultants Structural Engineers Seismic Strengthening Preliminary Assessment	110
Attachment 6	AHI Carrier (NZ) Ltd HVAC and Ceiling Space Report	114
Attachment 7	Site assessment	121
Attachment 8	Map 1 - Site assessment locations	123

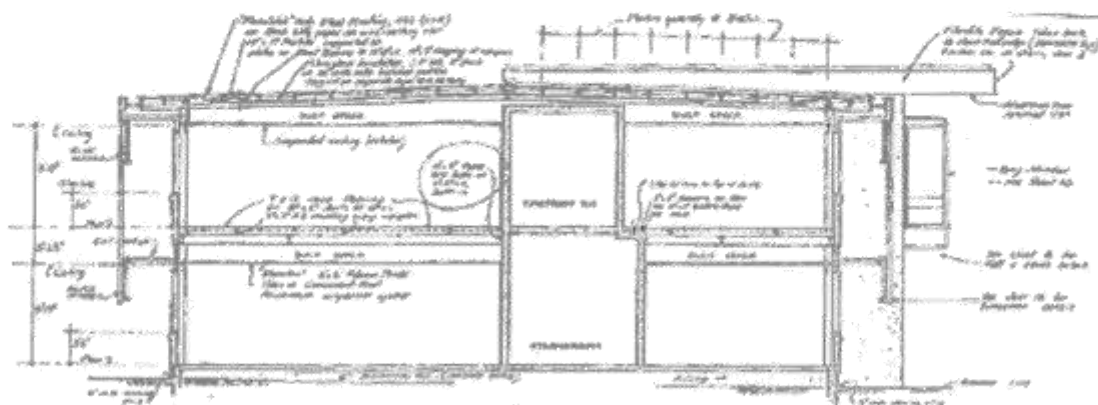
Figure 2

The original building is a two storey timber framed structure supported on shallow foundations. The timber first floor is supported on steel beams and the light metal roof is supported on timber purlins. The external walls consist of sill height concrete spandrel panels. Lateral loads are resisted by concrete shear walls. (Refer to Figure 2). For all available drawings refer to Appendix B.

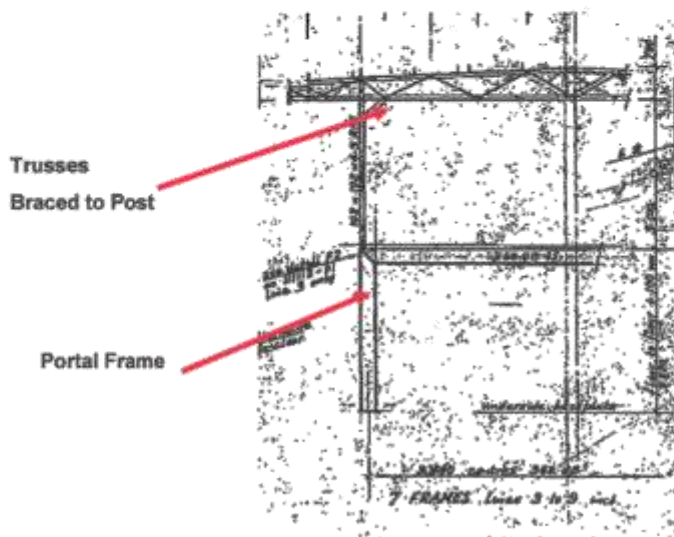
Lateral loads in this building are resisted by trussed portals at the upper level and by steel portal frames at the lower level in the short direction. Refer to Figure 3 for a cross section.
